# **JANE DAVIES CONSERVATION ARCHITECTURAL PAINT RESEARCH**

ARCHITECTURAL PAINT RESEARCH,  
BANQUETING HOUSE, LONDON  
2014 – 2018

This report summarises the architectural paint research (APR) undertaken in the Banqueting House by Jane Davies Conservation between 2014 and 2018. Paint research included the elaborate ceiling framework, wall frieze, pilasters, Corinthian capitals, balcony

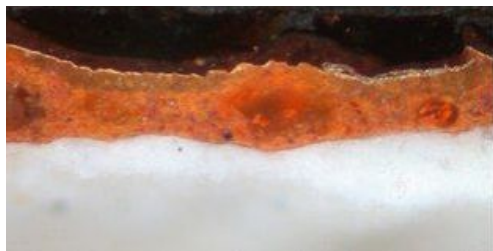
FIG. 3 ABOVE Cross-section sample from the curved planceer at the northern end of *Minerva* photographed under darkfield reflected light (2016/30). 200× magnification at capture; printed magnification not calculated. Showing Jones's first and second schemes.

Of ten samples taken from the planceers, only one bears evidence of paint pre-dating Soane's redecoration; sample 2016/30, from the curved planceer at the northern end of *Minerva*, gives the only indication of the early decoration of this element (FIGS 10 and 11). In this cross-section, Jones' 1630s scheme consists of a grained background over which there is gilding on pigmented oil size with dark painted or glazed details over the gold leaf. There are layers of varnish and paint between Jones' scheme and Soane's 19th-century redecoration, which are likely to relate to the overlapping of the second Jones scheme graining of the background based on its close similarity with the equivalent layers in sample 2016/35, where these layers are all clearly part of the same intervention.

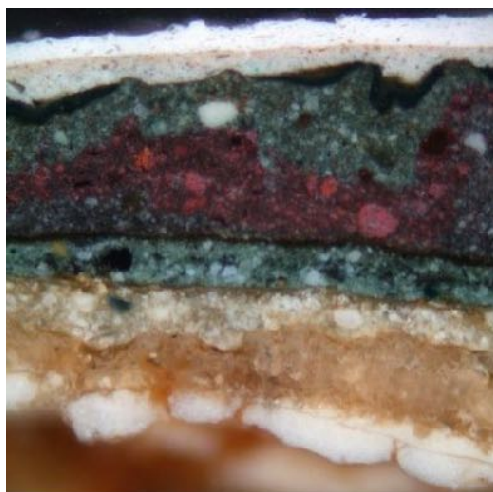
FIG. 4 ABOVE Cross-section sample from the south-east caisson spandrel of *Apotheosis* photographed under darkfield reflected light (2016/27). 200× magnification at capture; printed magnification not calculated. Showing Jones's first white and second pale blue decoration.

Seen in cross-section, the smalt-containing paint of the original caisson backgrounds is translucent and mixed with lead white (FIGS 4 and 8). All of the smalt-containing samples include some evidence that a shellac varnish (orange under ultraviolet illumination) was applied to the surface as part of an early intervention. In one sample (2018/17), a small flake of the earliest smalt-containing paint has detached and been re-adhered by the shellac which might suggest the shellac was applied after some time had elapsed. The original smalt may well have degraded to some extent, as it does not appear very strongly coloured in any of the cross-sections. Although it is of small particle size and therefore not the most expensive and brightest blue even when originally applied.<sup>4</sup> Although in an earlier phase of APR the smalt layers were interpreted as multiple layers of a single scheme, the

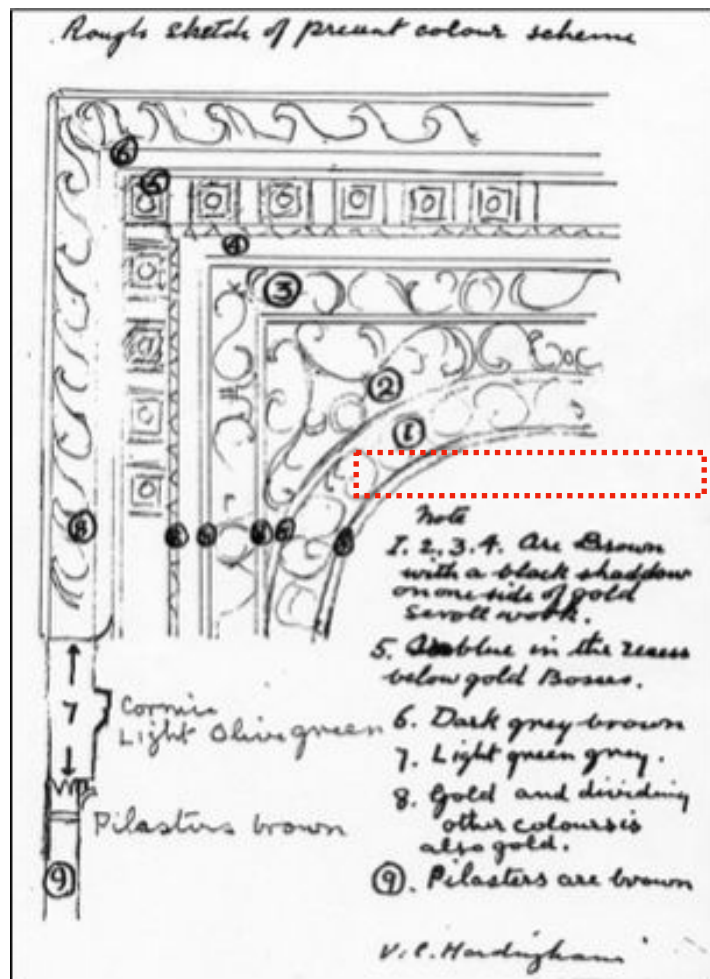
FIG. 5 ABOVE Sketch by V.C. Hardingham showing the colour scheme of the coffering in 1950. The note regarding the blue coffer soffits is highlighted with red.

also relate to Streater is the re-painting of the caisson backgrounds blue, with a second smalt- and lead-white-containing paint. This was applied over the shellac. The shellac at the intersection of the cyma reversa and planceer had developed cracks before the next layer of natural resin varnish<sup>1</sup> was applied suggesting some time had elapsed. This later varnish may be part of Kent's treatment, or may have been applied at some time between Streater and Kent's documented work. There is not a great deal of clear evidence of Kent's intervention although in some samples there is a brown paint layer which most probably relates to his work. Later, the caisson backgrounds were repainted blue with a paint mixture that included Prussian blue. The coffer soffits, which were originally painted with graining, were later painted with a Prussian-blue-containing paint mixture; this was still visible in the mid-20th century when it was documented by V.C. Hardingham (FIG. 5).<sup>2</sup> The two Prussian-blue paints are not from the same scheme, and the first on the caissons pre-dates Soane's restoration whereas the blue on the coffer soffits appears to be either co-eval with, or post-date Soane's work.

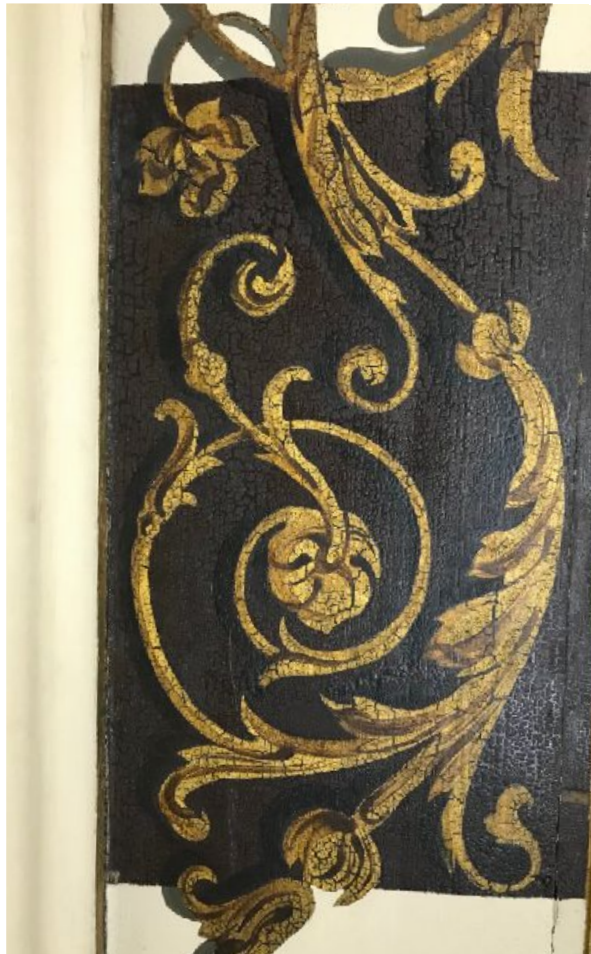
FIG. 6 ABOVE Detail of an uncovering trial on the planceer at the north end of the ceiling, revealing Soane's scheme. Note the dark shadows, which offer much more contrast with the gilding than the modern, opaque, greyish shadows visible at the top of the image.

over it. It appears that parts of Soane's re-graining were selectively varnished, possibly with a slightly pigmented varnish or glaze.

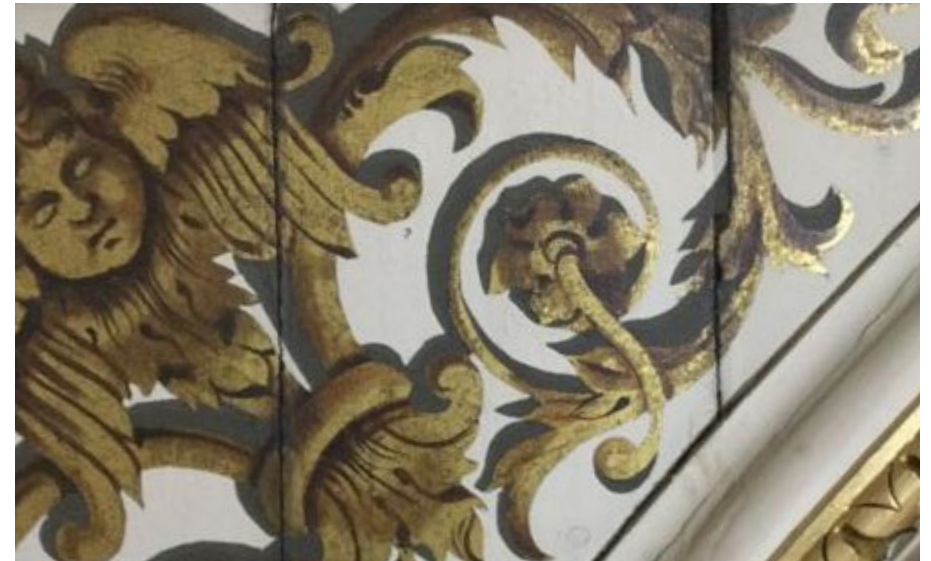
FIG. 7 Detail of the south-east spandrel caisson of *Apotheosis*, showing the visible planks of the original timber support.

Smalt-containing paint and early gilding from Jones' 1630s scheme, has been identified in samples from the south-east and south-west spandrel caissons of *The Apotheosis of James I*. Both of these caissons have a substrate made of planks, clearly visible to the naked eye (FIG. 7). In other caisson samples, from around *Apotheosis* as well as the two oval corner paintings, *Hercules* and *Minerva*, the earliest paint is from Soane's scheme (FIG. 9) and the substrate is not made up of visible planks suggesting that entire caissons were replaced during Soane's intervention, when Turner *et al.* were paid for 'preparing the frames and making parts new for the paintings and preparing spandrils for ditto'.<sup>3</sup> In replaced caissons, Soane's graining sits directly on a softwood substrate.

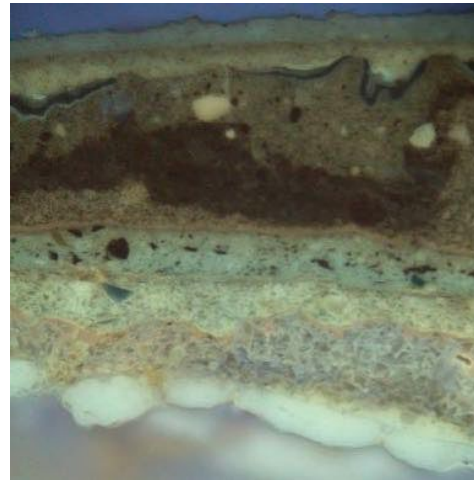
FIG. 8 Cross-section sample from the south-east caisson spandrel of *Apotheosis* photographed under ultraviolet light with Leica filter cube A (2016/27). 200× magnification at capture; printed magnification not calculated.

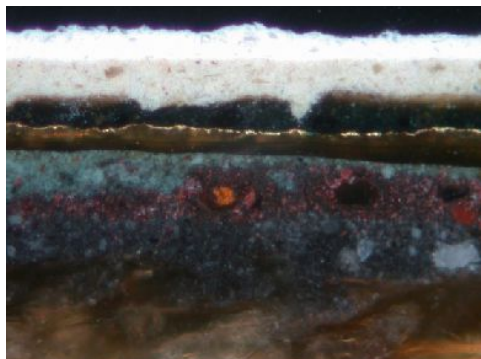
FIG. 9 Cross-section sample from the north-west caisson spandrel of *Apotheosis* photographed under darkfield reflected light (2014/4). 200× magnification at capture; printed magnification not calculated.

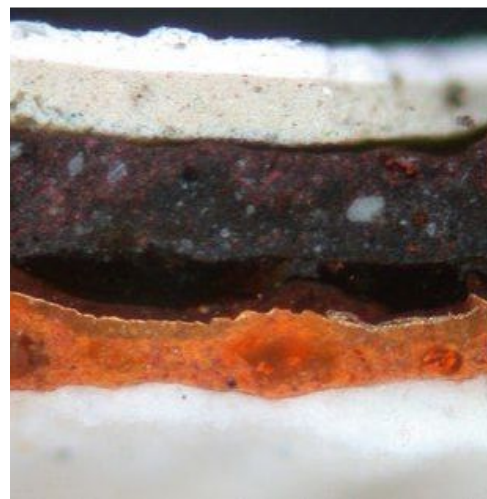
FIG. 10 Cross-section sample from the curved planceer at the northern end of *Minerva* photographed under darkfield reflected light (2016/30).  
200× magnification at capture;  
printed magnification not calculated.

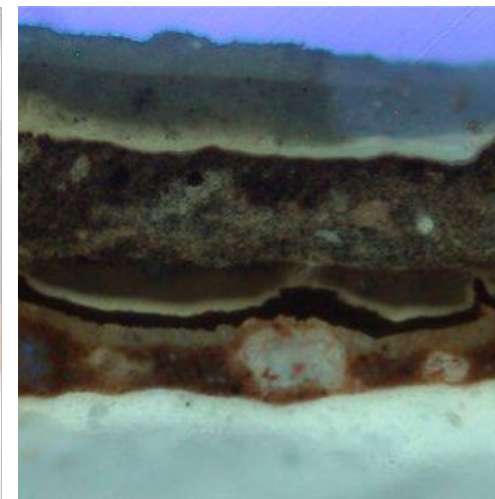
FIG. 11 Cross-section sample from the curved planceer at the northern end of *Minerva* photographed under ultraviolet light with Leica filter cube A (2016/30).  
200× magnification at capture;  
printed magnification not calculated.

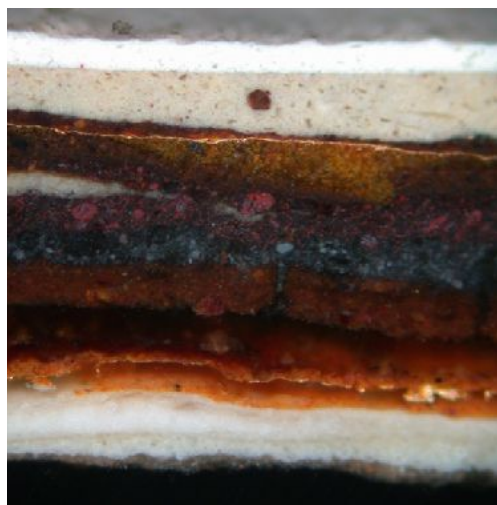
FIG. 12 Cross-section sample from large cyma reversa north-east (*Minerva*) section, photographed under darkfield reflected light (2014/15). 200× magnification at capture; printed magnification not calculated.

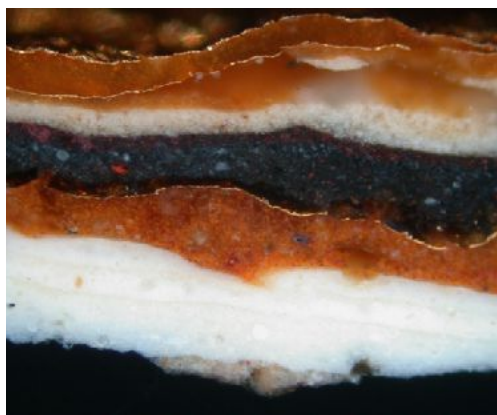
FIG. 13 Cross-section sample from large cyma reversa north-east (*Minerva*) section, photographed under ultraviolet light with Leica filter cube A (2016/30). (2014/15). 200× magnification at capture; printed magnification not calculated. The shellac layer between Jones' second scheme and Kent's material appears bright orange in UV and had already developed cracks when it was coated with a natural resin varnish (bright greenish-blue in UV); likewise, the dark brown that we attribute to Kent had developed cracks by the time Soane's graining was applied

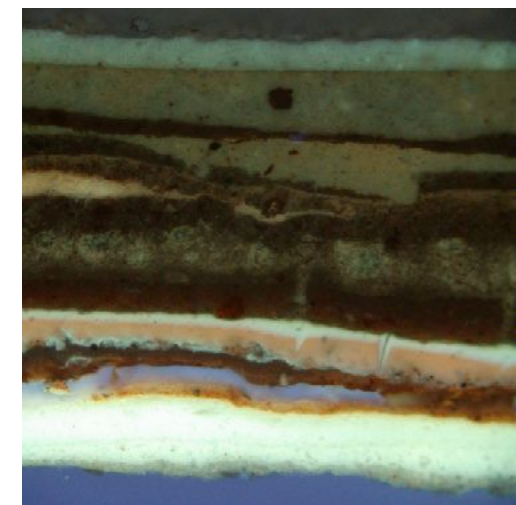
FIG. 14 Cross-section sample from small cyma reversa between spandrel caisson and rectangular section of planceer, north-east (*Minerva*) section, photographed under darkfield reflected light (2014/16). 200× magnification at capture; printed magnification not calculated.

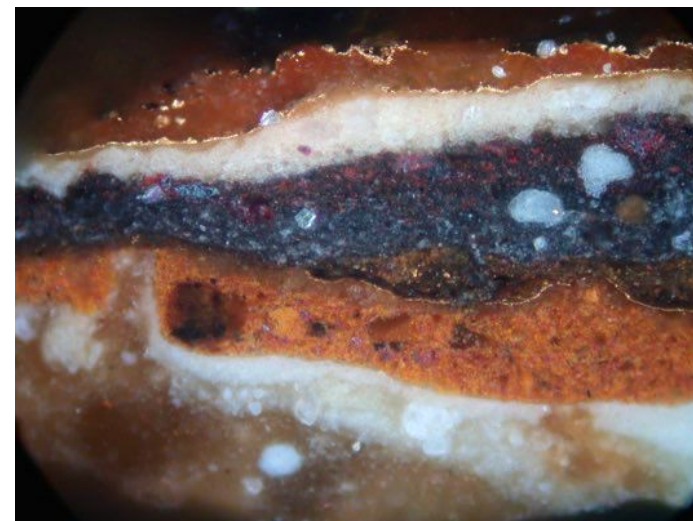
FIG. 15 Cross-section sample from arris of gilded frame around *Minerva*, north end, photographed under darkfield reflected light (2018/14). 500× magnification at capture; printed magnification not calculated.

Somewhat surprisingly, the vast majority of samples taken from the gilded frames around the paintings – even some of those taken from areas thought *in situ* to possibly be repairs – bear evidence of Jones' original paint schemes (FIG. 15). One of the samples from the frame arris of *Union of Crowns* does not bear any paint earlier than Soane's scheme, but a sample from a few millimetres away taken from the moulding of the frame rather than the arris has evidence of Jones' paint, further supporting the theory that the flat planceers were stripped at this point.

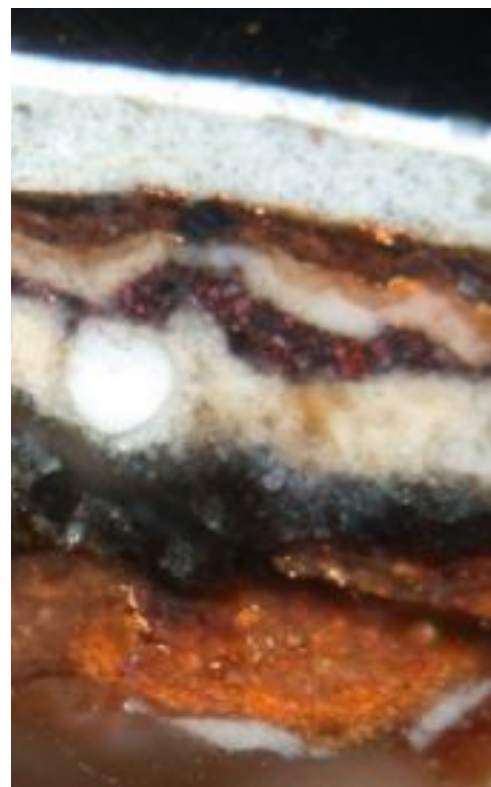
FIG. 16 Cross-section sample from vertical edge of guilloche edge band at south end of ceiling, photographed under darkfield reflected light (2016/8). 200× magnification at capture; printed magnification not calculated.

The placement of gilding on the vertical edges of the guilloche remains slightly unclear. A sample from the edge of the white painted area (2016/8) appears to show gilding from Jones' second scheme and certainly at Soane's time, which would indicate that the region might have been gilded until it was painted in the 20th century (FIG. 16); however, a sample from further along the vertical edge (2016/9), also currently painted white, shows continuous graining schemes with no evidence of gilding (FIG. 17). This might suggest that the boundary between gilding and graining was different in the past, not necessarily corresponding with the boundary between gilding and white visible at the time of sampling.

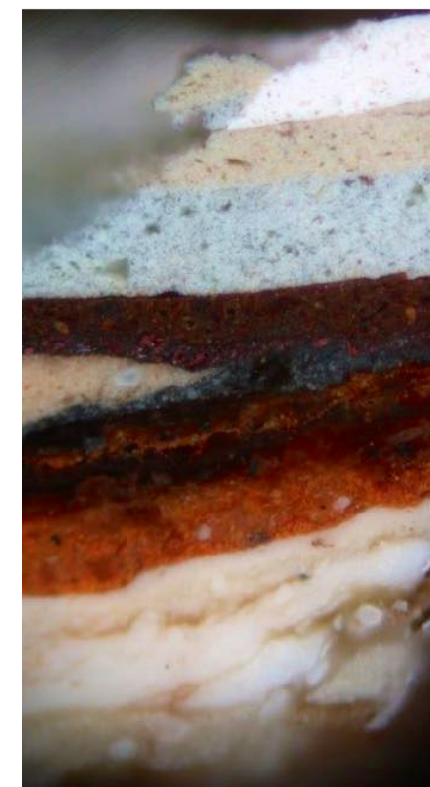
FIG. 17 Cross-section sample from vertical edge of guilloche edge band near *Apotheosis*, photographed under darkfield reflected light (2016/9). 200× magnification at capture; printed magnification not calculated.

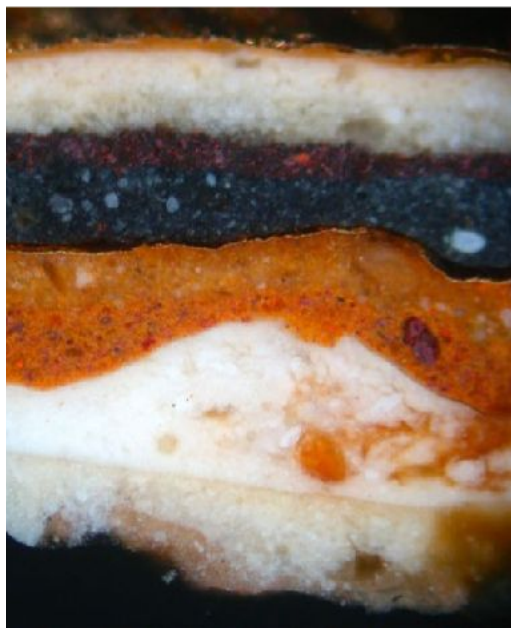
FIG. 18 Cross-section sample from waterleaf and dart moulding of coffer adjacent to *Hercules*, photographed under darkfield reflected light (2014/12). 200× magnification at capture; printed magnification not calculated.

(FIG. 18).

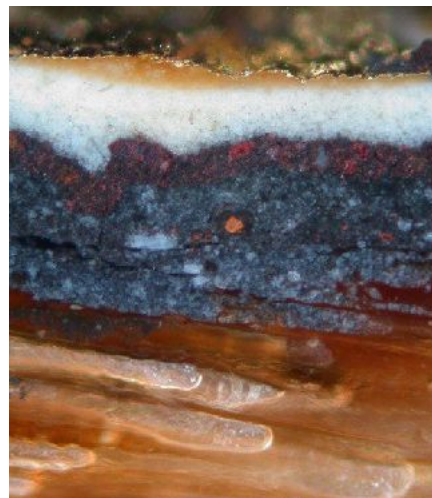
FIG. 19 Cross-section sample from repaired waterleaf and dart moulding at north end of *Union of Crowns*, photographed under darkfield reflected light (2014/12). 200× magnification at capture; printed magnification not calculated.

The area at the northern end of *Union of Crowns* which appeared slightly different in style is a 19th-century repair. The only decorative scheme evident in this sample is Soane's, which consists of graining followed by gilding (FIG. 19). The substrate of this area is an open-grained timber with the appearance of softwood, which in cross-section closely resembles the support of the non-original caissons which were replaced during Soane's era.

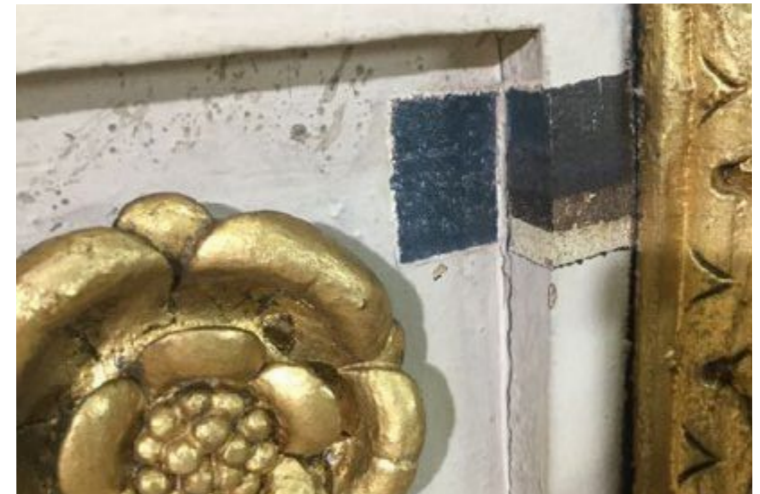
FIG. 19 Detail of an uncovering trial in the coffer soffit, north-east corner of *Union of Crowns*, showing 19th-century blue background.

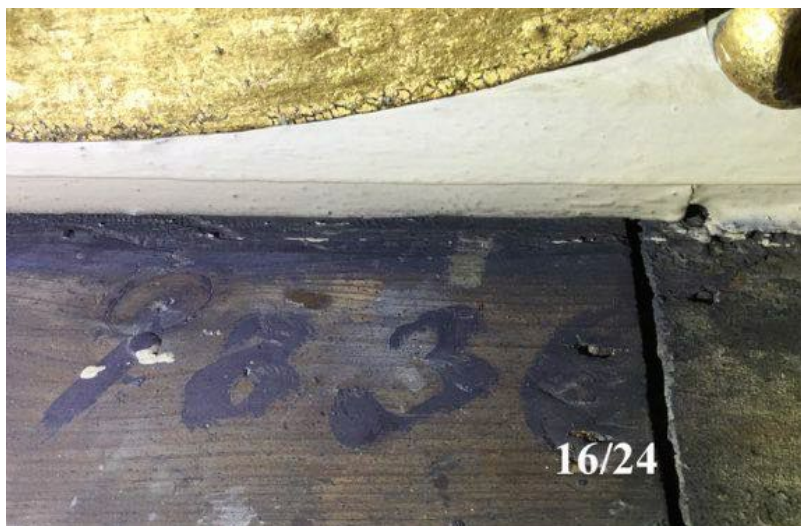
FIG. 20 Detail of the date painted on the flat top of the east-wall cornice showing sample location.

The date '1836' on top of the cornice at the east side was painted using the same grey paint as is found within the Soane decoration elsewhere (2016/24) (FIGS 20 and 21).

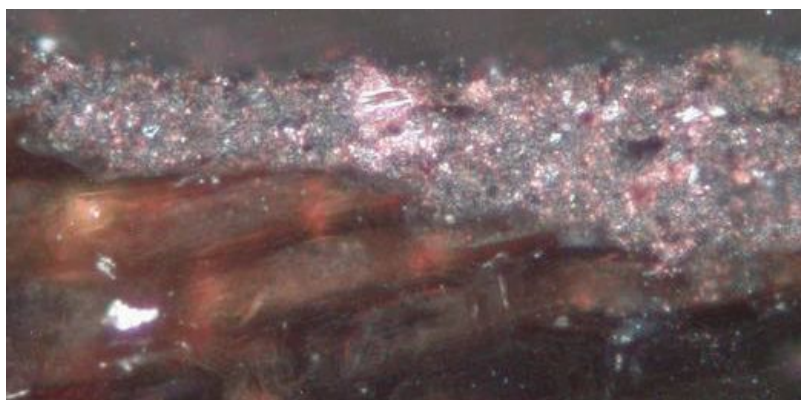
FIG. 21 Cross-section sample from the date on top of the cornice, photographed under darkfield reflected light (2016/24). 200× magnification at capture; printed magnification not calculated.

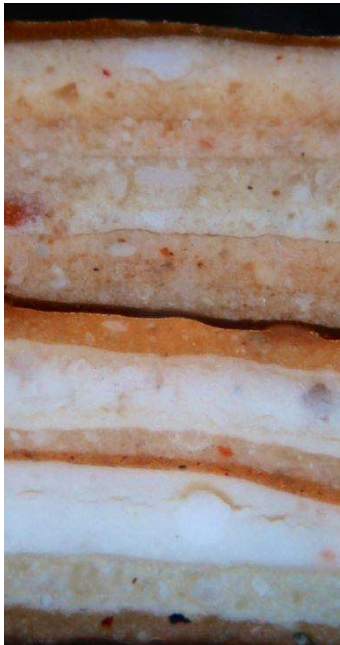
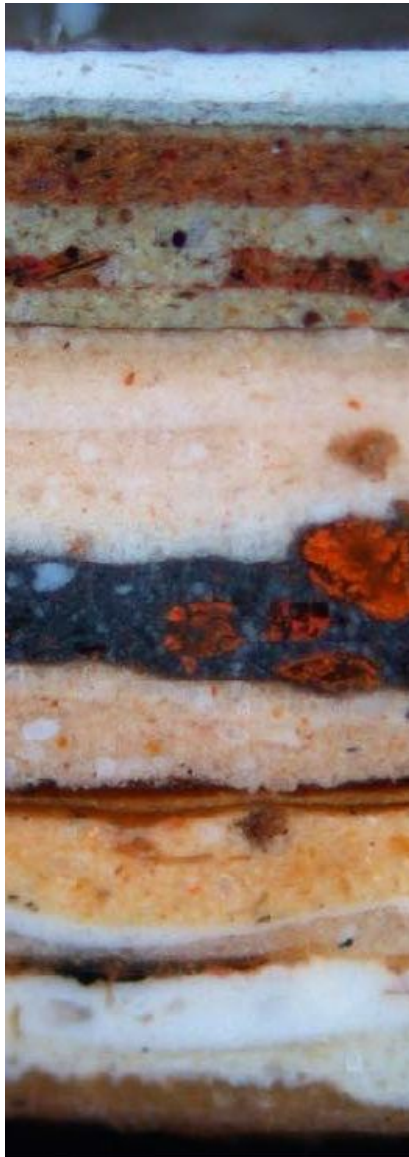
FIG. 23 (below) Cross-section sample from the cyma revers moulding above the entablature frieze, photographed under darkfield reflected light (2016/ 48). 200× magnification at capture; printed magnification not calculated.

Two samples from the cyma reversa moulding above the entablature frieze were taken near the north-west corner of *Union of Crowns* (2016/46 and 2016/48). In both samples the first Inigo Jones scheme, which elsewhere generally consists of lead-white oil paint or distemper, includes a pale orange-brown paint layer over lead white (FIG. 23), which suggests two possibilities: on one hand, it may be evidence of figurative paint of white 'marble' finish on a translucent white undercoat or on the other, as the orange-brown is not dissimilar in appearance to the pigmented size of the slightly later Jones scheme seen elsewhere, it may indicate that this element was gilded, although if this were the case the

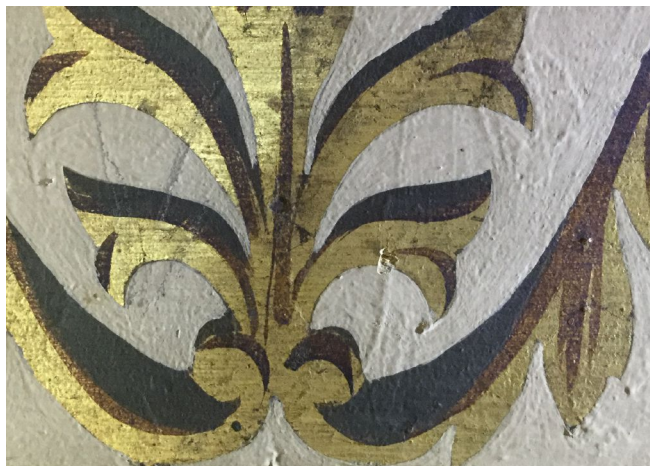
FIG. 24 Detail of well-preserved Soane-era gilded decoration on the anthemion fascia at the north-west corner, near sample 2018/12 site, showing quality of gilding and design attributed to Soane, overlying earlier decoration visible in raking light.

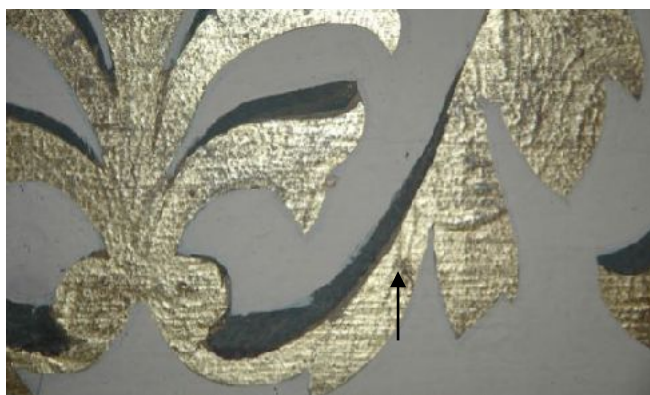
FIG. 25 Detail of the 'weak' foliate pattern on the anthemion fascia sampled as 2014/22, showing continuous gilding and no glazing. The absence of glazing might suggest the area has been overcleaned in the past. In addition, in raking light a different design is partially visible.

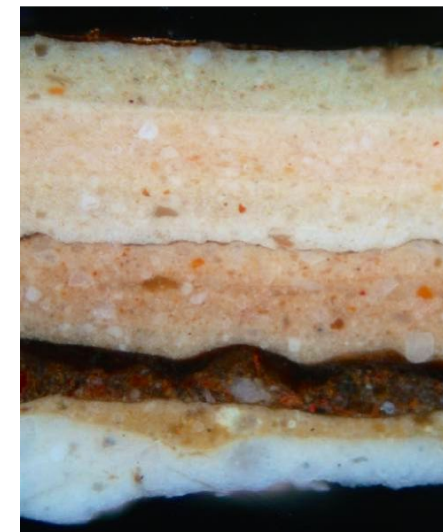
FIG. 26 Cross-section sample from the 'weak' foliate pattern on the anthemion fascia, photographed under darkfield reflected light (2014/22). 200× magnification at capture; printed magnification not calculated.

Image shows dark brown paint of design of Jones' second scheme, lead-based buff paint possibly attributable to Streater with surface dirt, followed by Soanes paint layers, including characteristic grey-green with yellow ochre and, uppermost, gilding dating from Soane's scheme or later.

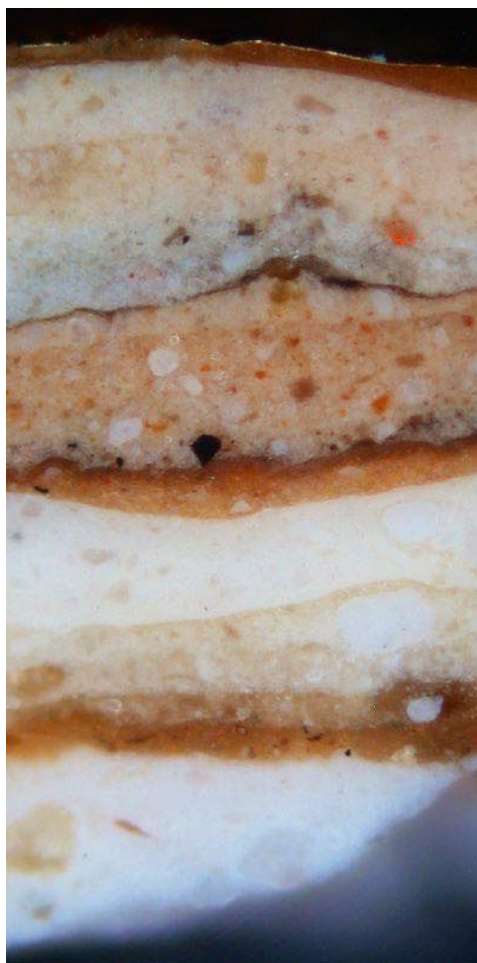
FIG. 27 Cross-section sample from volute leaf tip of north-east Corinthian capital, photographed under darkfield reflected light (2016/54). 200× magnification at capture; printed magnification not calculated.

prepared with another layer of lead white, followed by pigmented size and gold leaf. From this point onwards the Corinthian capitals were gilded. A sample from the most recent phase of analysis (2018/20) provided the first physical evidence that the recessed background surfaces of the capitals were gilded from the second Jones scheme, and that gilding in this region is not a later introduction.

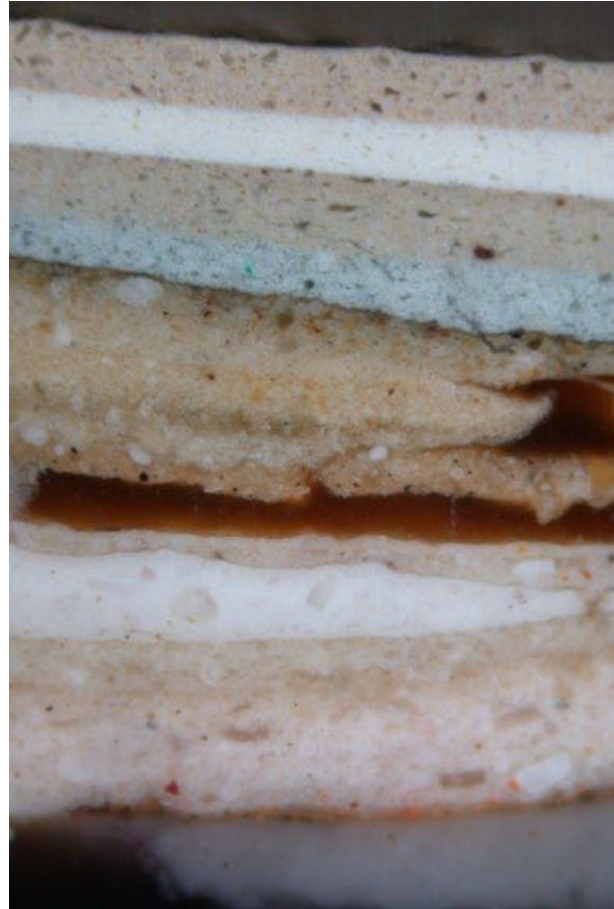
FIG. 28 Cross-section sample from wall-frieze background, east wall, photographed under darkfield reflected light (2016/5). 200× magnification at capture; printed magnification not calculated.

figurative elements differ from one another; in both regions, though, the earliest paint layers of the first Jones painting – which pre-dates the figurative frieze scheme – consist of lead-white-based paint. Some of these early lead-white paint layers include red lead and other materials; some are bound in distemper and some in oil. An oil-based lead white paint layer with little adulteration probably constitutes the earliest pre-figurative finish of 1619–1622. In some regions this layer seems to have been left more-or-less exposed in the original figurative wall frieze, which dates from the second Jones decoration of 1635–1637. In the original figurative frieze decoration, the background appears to have been a lead-based pale buff colour, and the figurative elements blocked in with an opaque orange-brown paint mixture, before modelling was applied with darker brown medium-rich glazes. During Streater's intervention, varnish was applied to some parts of the wall frieze but little else seems to have been done. In the 19th century, probably as part of Soane's restoration, brown, grey and orange paint mixtures were used to strengthen and repaint the figurative elements and the background was repainted with several layers of warm buff paint.

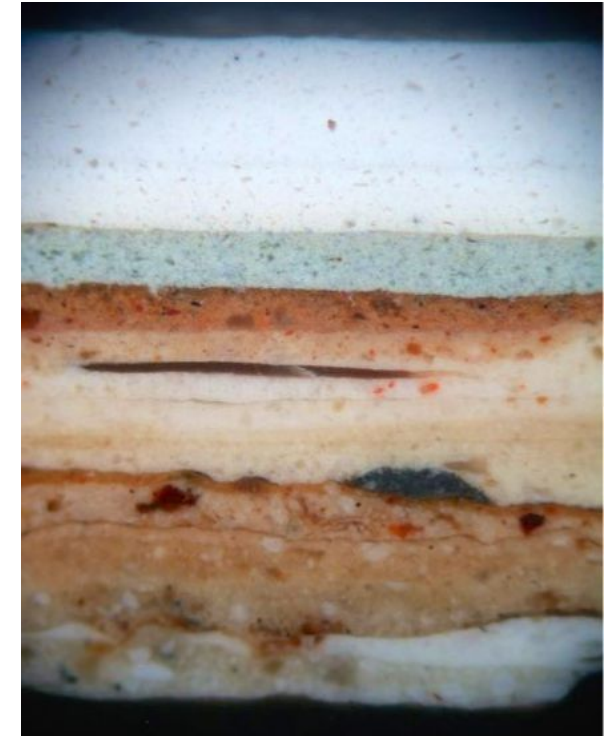
FIG. 30 Cross-section sample from baluster of east-side balcony, photographed under darkfield reflected light (2018/38). 200× magnification at capture; printed magnification not calculated.

The balcony and minstrels' gallery woodwork was later repainted pale brown/red-brown with zinc-white-containing paint, of which there are at least two separate schemes; based on the presence of zinc white, these must date from some time after *c.*1850. In the latter part of the 20th century, the woodwork was painted beige and finally the white that we see today.

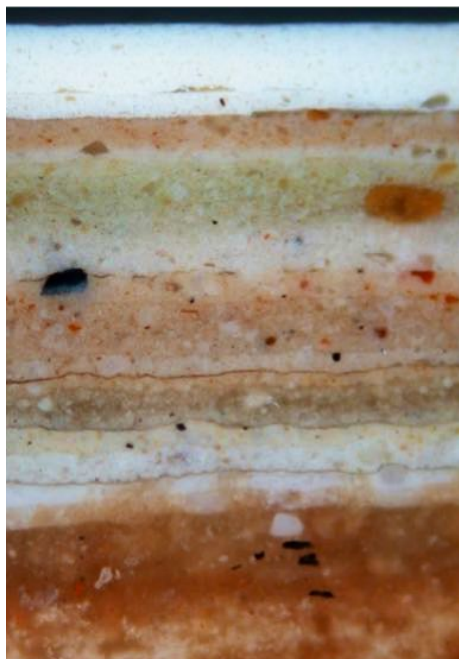
FIG. 31 Cross-section sample from the window reveal of the northernmost window at the first-floor level, photo-graphed under darkfield reflected light (2014/34). 200× magnification at capture; printed magnification not calculated.

Despite extensive removal and repair of material around the windows during Soane and Smirke's intervention,<sup>12</sup> four out of five samples taken from window splays show a relatively full decorative history for the walls (FIGS. 31 & 32). This includes evidence of original distempers, followed by Jones' white paint, over which there are numerous stone- and buff-coloured paint layers, often with dirt between them, which account for the phases from the

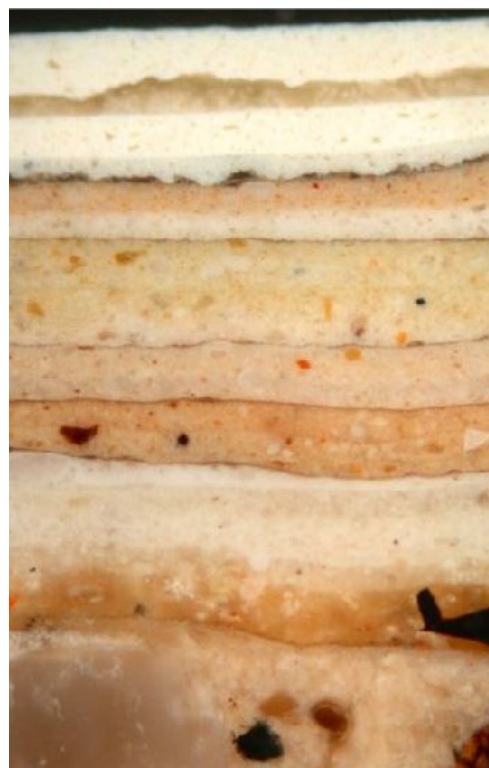
FIG. 32 (below) Cross-section sample from the south-side, ground-floor window reveal of the second-from-north west-wall window, photographed under darkfield reflected light (2014/34). 200× magnification at capture; printed magnification not calculated. A thick layer of dirt is visible between the late-19th-century paint and the modern schemes, possibly indicating damage to the window during WWII.

A window-splay sample from the south-side, ground-floor window reveal of the second-from-north west-wall window (2014/31) includes a very thick layer of dirt between the late 19th-century paint and the more modern layers (FIG. 32), which may relate to the Second World War. This is not seen to the same degree on most of the window-splay or wall samples; it would be interesting to investigate whether there is a record of this particular window having been damaged at this stage. On the ground-floor level few aesthetic changes seem to have taken place on the walls. In a sample from the lower-level wall face (2014/30), a lower lead-white layer is visible, which may correspond to the second scheme by Jones in the 1630s, followed by several buff or stone-coloured paint layers, which are likely to correspond to Streater, Kent, and Soane and Smirke's interventions, and possibly even the later-19th-century scheme of 1888. A pale-grey paint layer over the buff layers includes lead and dates from the later 19th century or 20th century. This is followed by up to three layers of cream or very-pale-buff modern paint.

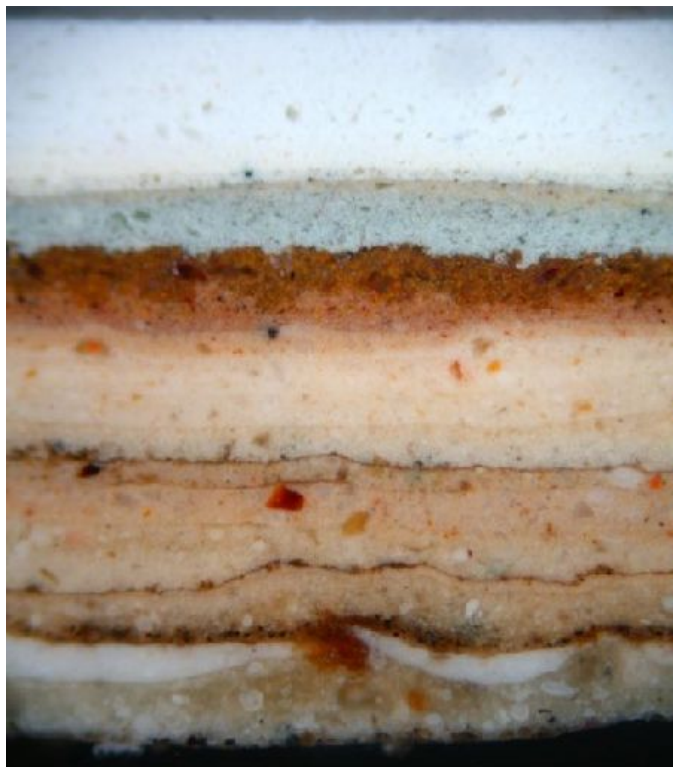
FIG. 33 Cross-section sample from the bead moulding of the entablature, photographed under darkfield reflected light (2014/26). 200× magnification at capture; printed magnification not calculated.

There is some evidence that during Jones’ second scheme the pilasters and entablature moulding regions were painted with a white *faux-marble* finish (2014/26, 2014/28, 2014/30) For example, sample 2014/26 (FIG. 33 below) shows a dark paint layer immediately on the surface of the densely pigmented pure white Jones’ decoration. Sample evidence suggests that after Jones’ second scheme the pilasters, lower-tier pilaster capitals, entablature moulding and gallery consoles, including the soffits, were painted a similar pale buff or stone colour to the walls and remained like this for most of their early history, including during Soane’s redecoration.
