# JANE DAVIES CONSERVATION

## Architectural Paint Research

### 4 & 5 Tower Green, Tower of London

**May 2018**

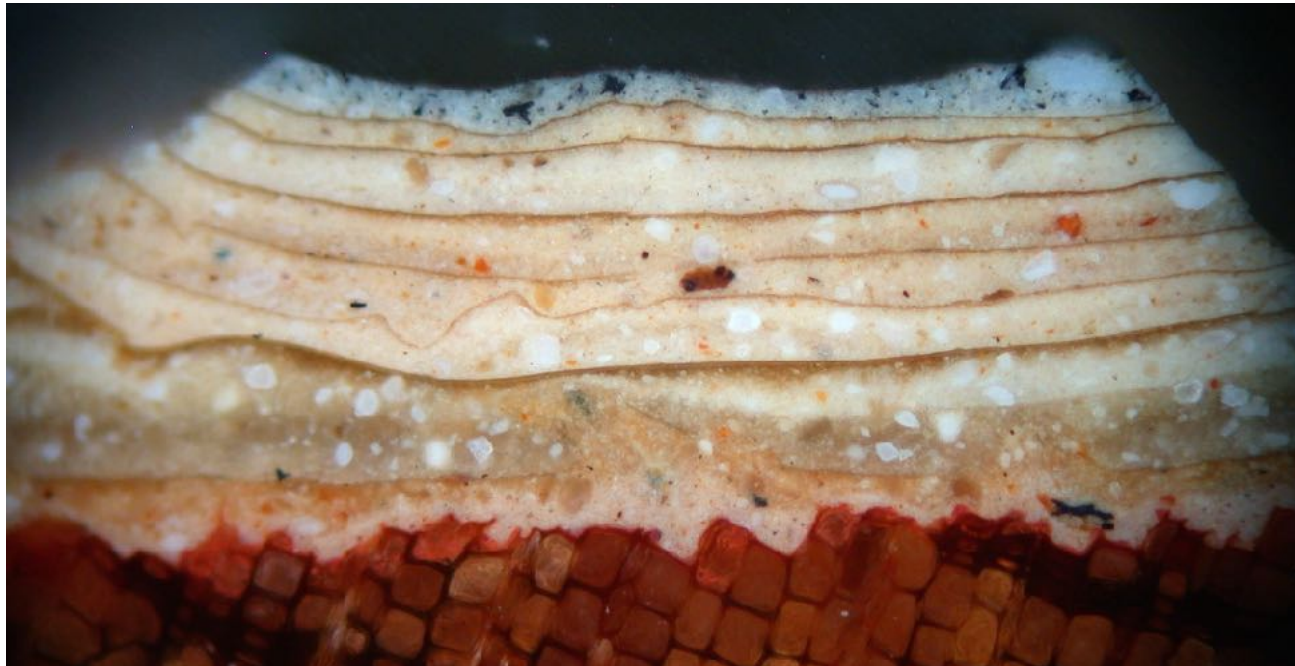
Sample 150  
(fragment 2)  
showing the earliest  
paint schemes and  
timber substrate. The  
sample is from  
panelling on the ground  
floor near front door of  
5 Tower Green  
photographed in dark-  
field light at 200×  
magnification.  
Printed magnification  
not calculated.

Sample 150 from the entrance hall panelling of house 5 is one of the most complete samples within either house and has evidence of up to 50 painted decorations, including material which appears to date from the 1680s. This sample bears evidence of an off-white decoration over the priming. Others, such as sample 171 from the ground floor door between the houses, appear to show painted graining very similar to the fictive panelling currently visible in the first floor north room of house 5 (samples 288 to 293).

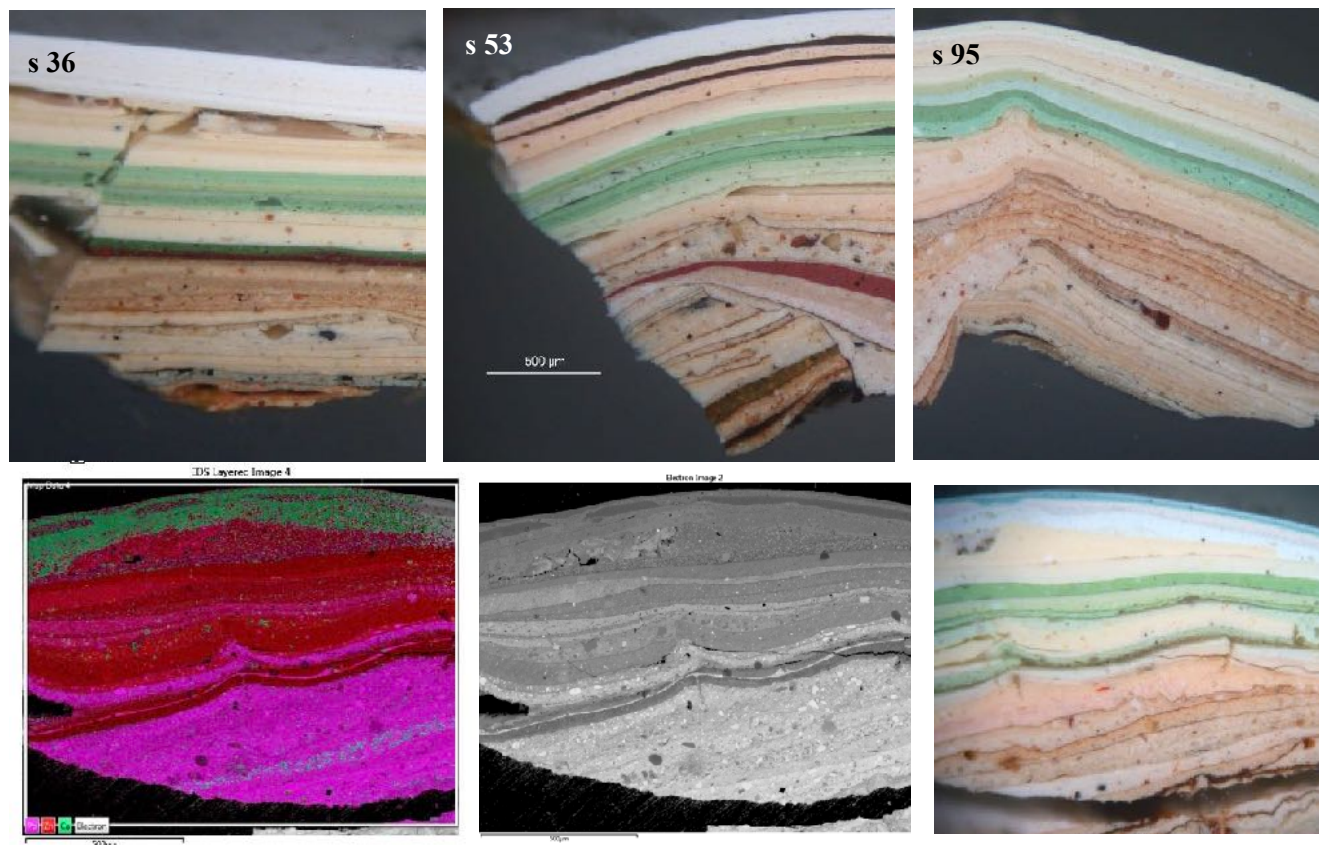
The samples pictured show the typical general paint history: timber, *faux* graining or off-white early decorations, followed by numerous buff/beige decorations before the introduction of repeated greens in the mid-19th century, prior to their replacement with modern pale and off-white schemes.

The elemental map, far left, shows lead (Pb) in pink, zinc (Zn) in red and calcium (Ca) in green. The layers of the sample capture the typical transition from lead-based paints to zinc-containing paints and a further change to titanium-white-based paints. The upper layers contain titanium as well as calcium.

*Above, top row, left-right:* Sample 36 from house 4, main ground floor room dado rail; sample 53 house 4 stairs from ground to first floor, baluster; sample 95 from house 5, ground floor, middle room, horizontal wall plank panelling. All photographed in cross-section under dark-field illumination at 50× magnification. Printed magnification not calculated.

*Above, bottom row, left-right:* Sample 237 from house No. 5, second floor, south room, window mullion, backscattered electron image mapped to show lead (Pb) in pink, calcium (Ca) in green and zinc (Zn) in red; backscattered electron image; in cross-section under dark field illumination at 50× magnification. Printed magnification not calculated.

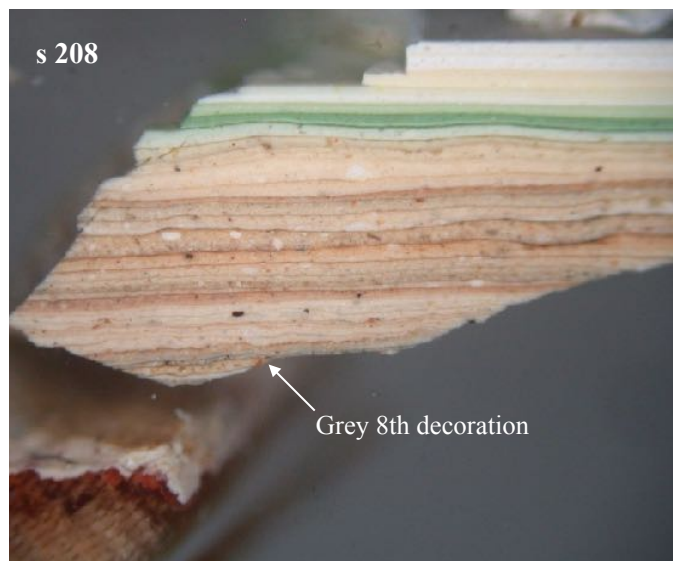
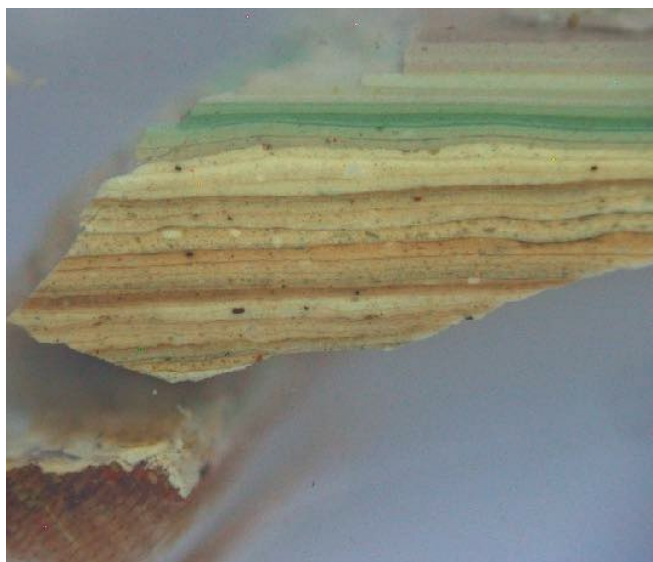
Sample 208 from No. 5, staircase from first to second floor, (5S.15 door frame roll moulding) shows a relatively typical and full sequence of decorations. It starts with the second type of dark-red priming used as the third scheme in house 5. It includes the characteristic grey layer of the eighth scheme, followed by numerous (in this case 20) beige and buff schemes before the introduction of green decorations from the mid-19th century onwards. Modern pale decorations can be seen at the top of the sample.

*Above, top row, left-right:* Sample 208 from house 5, staircase from first to second floor, (5S.15 door frame roll moulding) under dark-field reflected light; sample 208 under UV illumination with Leica filter cube A.

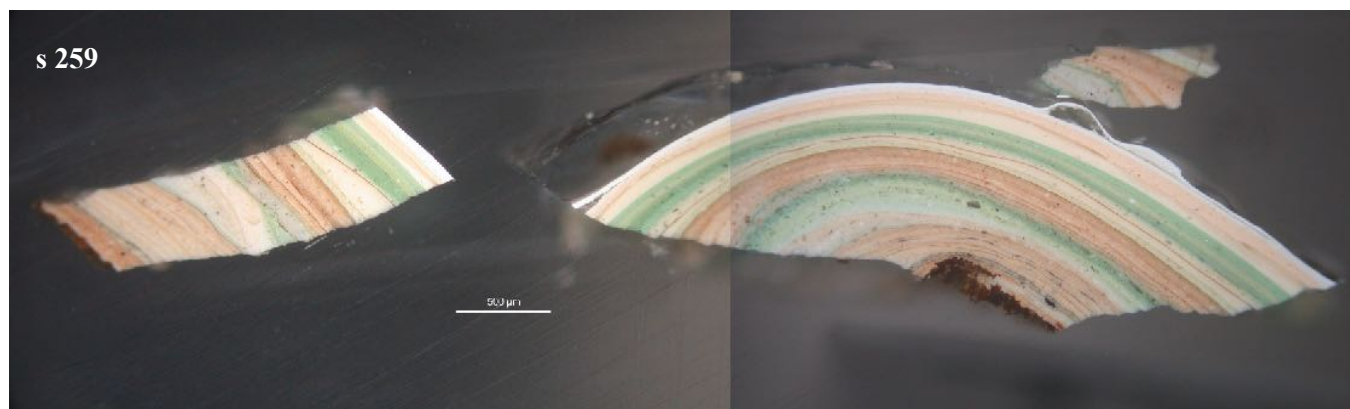
Sample 259 has evidence from the fifth decoration onwards, including the grey eighth decoration, and a pale blue-green as the 17th decoration, repeated with slight variation in hue at 18th and 19th decorations, followed by five or more buff schemes until the 19th-century introduction of several green schemes (24-28 here). The 18th-century green/pale-blue schemes on the panelling of the main ground floor room, house 4, with the use of more expensive pigments to create bright interior decoration confirms the high status of this domestic interior.

*Bottom:* Composite image of all fragments of sample 259. All photographed in cross-section under dark-field illumination at 50× magnification. Printed magnification not calculated.

*Far left:* Sample 259 (panelling revealed by removal of asbestos panelling, main ground-floor room of house 4). This sample has evidence from the fifth decoration onwards, including the grey eighth decoration, and a pale blue-green as the 17th decoration, repeated with slight variation in hue at 18th and 19th decorations, followed by five or more buff schemes until the 19th-century introduction of several green schemes (24-28 here). Sample photographed at 200× magnification under dark-field light.

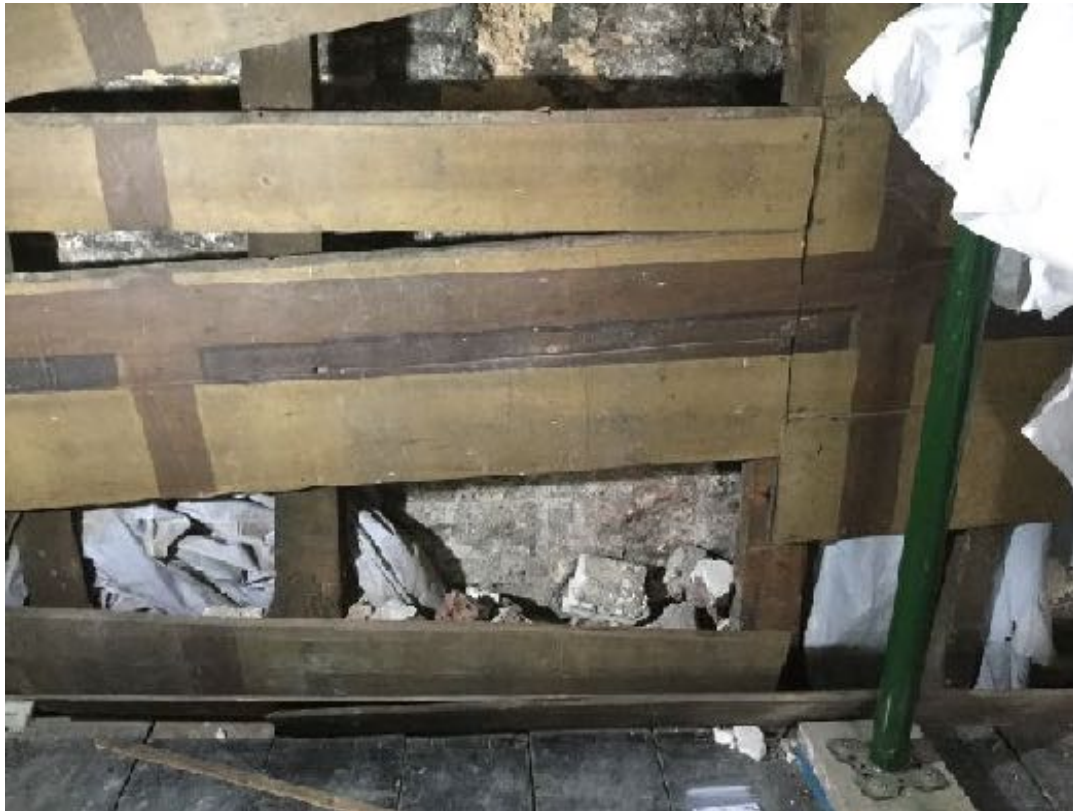
*Above left:* General view of the painted panelling on horizontal boards, south side of the first floor north room of house 5.

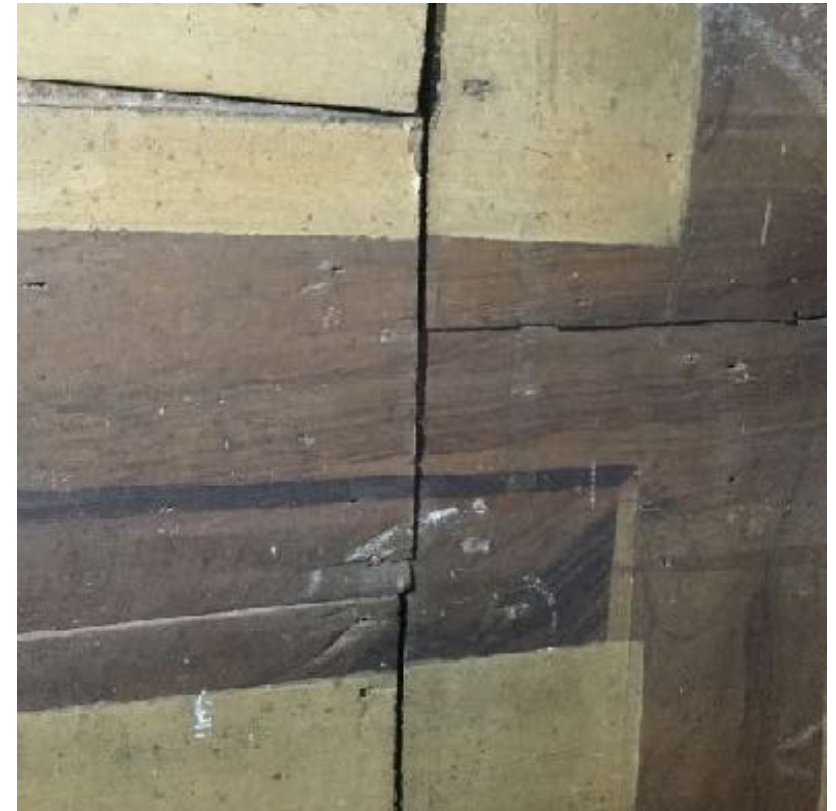
*Above right:* Detail of original 'walnut' graining and subsequent oak panelling. Applied mouldings are assumed to have been present as part of the oak graining, but are now missing.

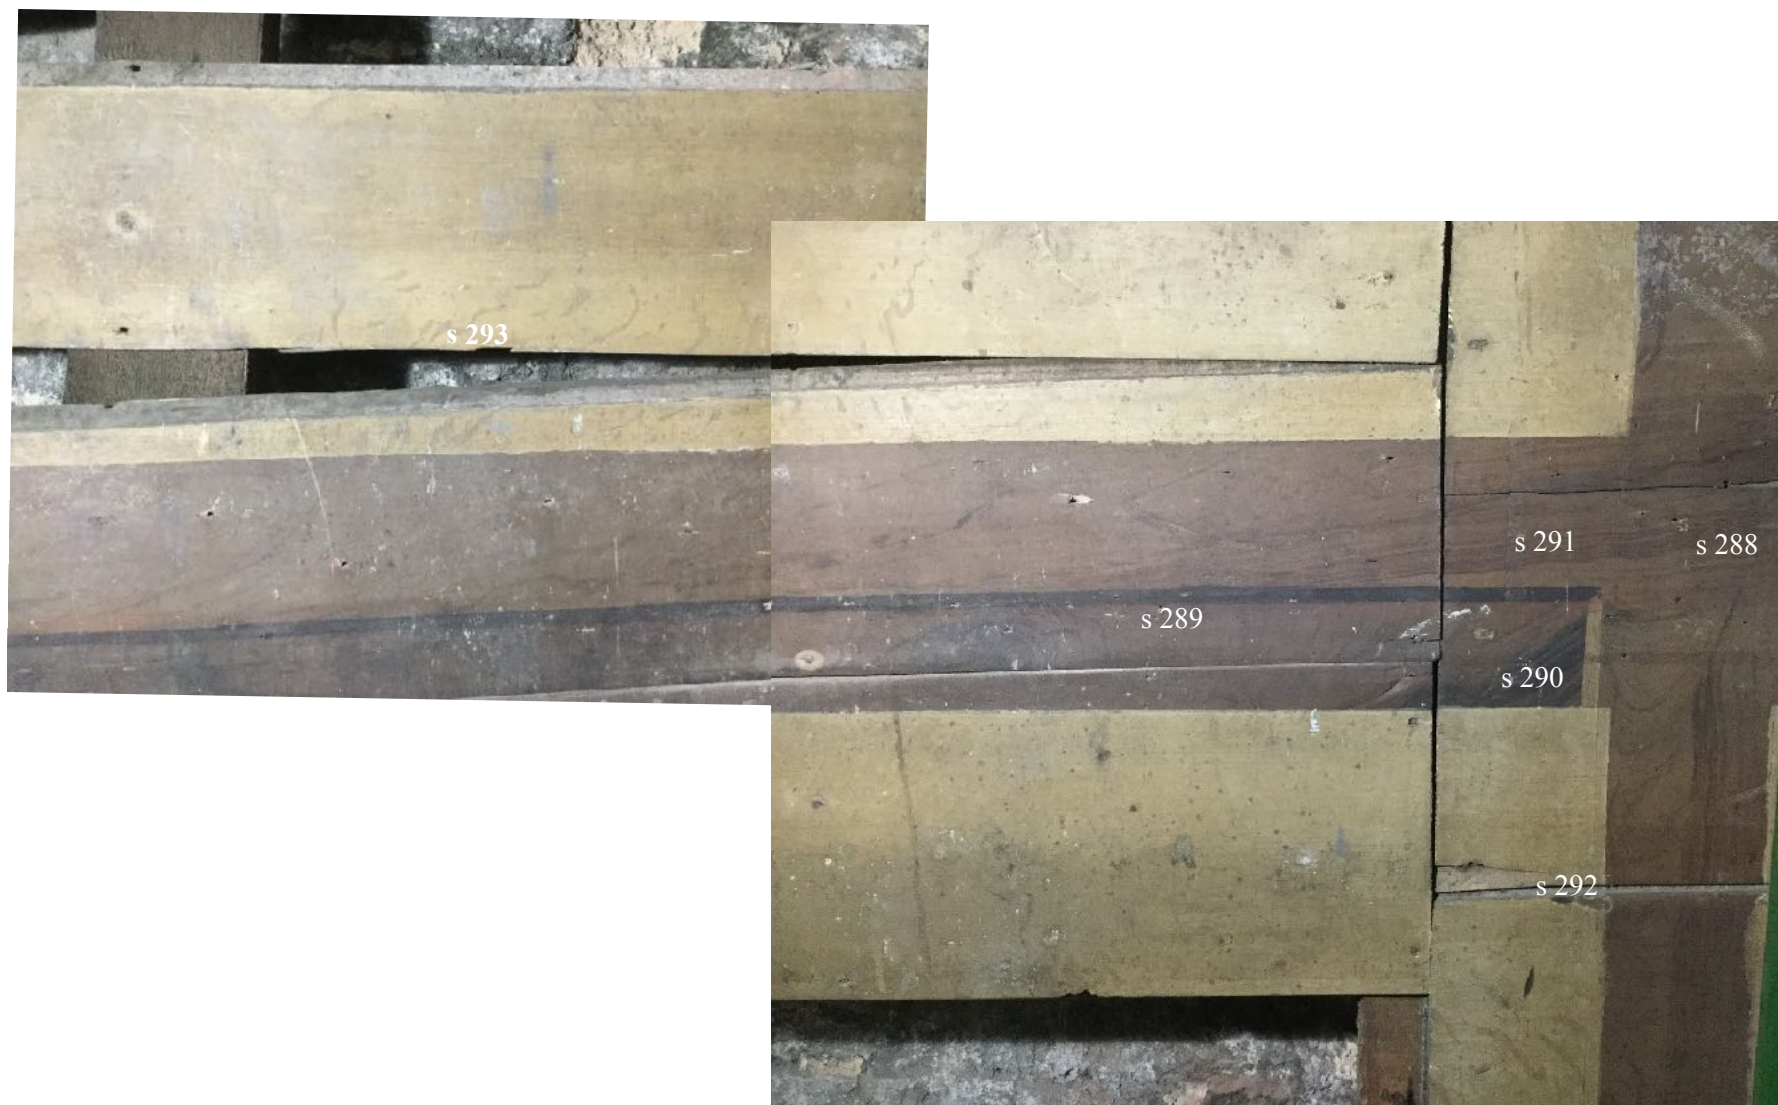
*Above:* Composite image showing sample locations on fictive panelling showing sample locations.

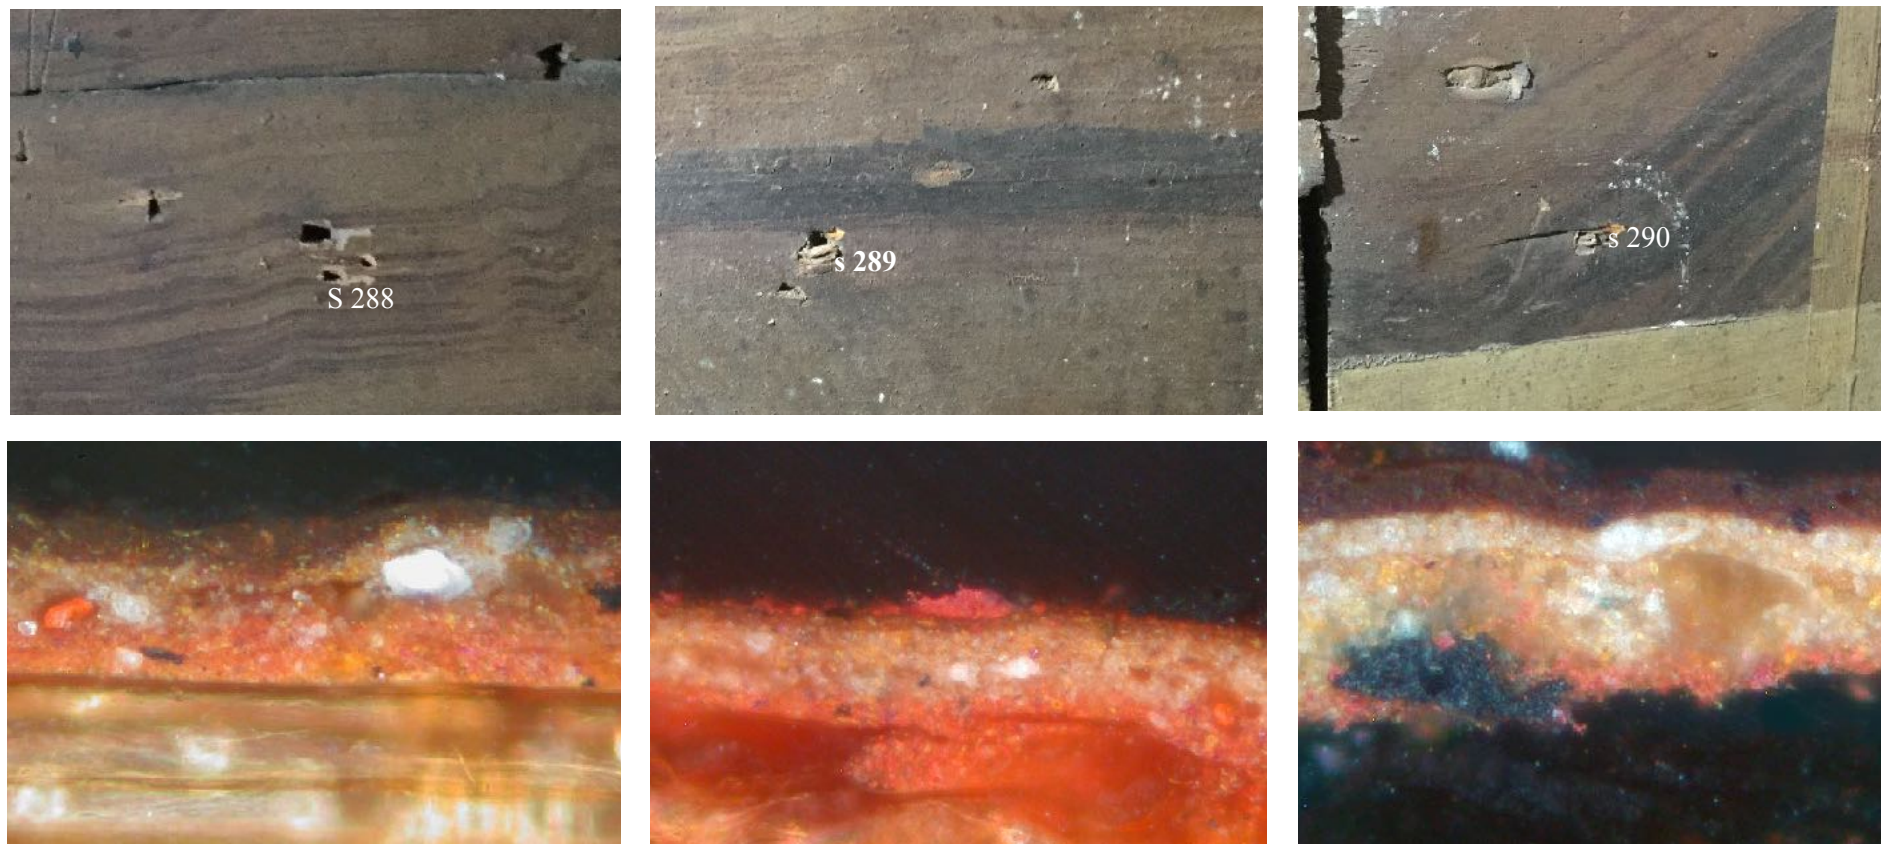
*Above left:* Sample 288 location (top) and in cross-section (bottom); *above centre:* sample 289 location (top) and in cross-section (bottom); *above right:* sample 290 location (top) and in cross-section (bottom). Cross-sections photographed under dark-field reflected light at 500× magnification. Printed magnification not calculated.

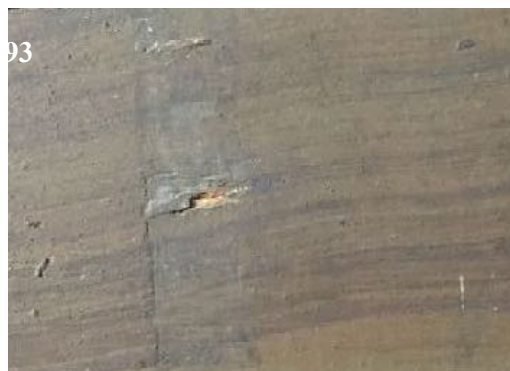
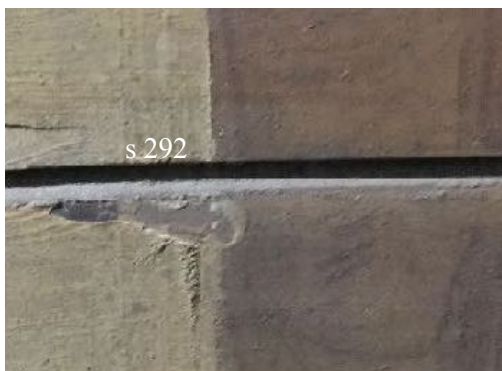
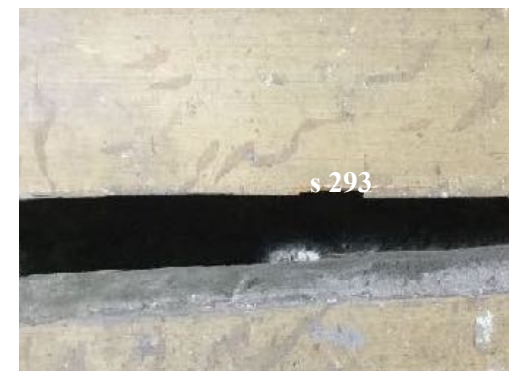
*Above left:* Sample 291 location (top) and in cross-section (bottom); *above centre:* Sample 292 location (top) and in cross-section (bottom); *above right:* Sample 293 location (top) and in cross-section (bottom). Cross-sections photographed under dark-field reflected light at 500× magnification. Printed magnification not calculated.

The red lead/red iron oxide priming can be clearly seen on and within the upper cells on the timber substrate on samples 291 and 293. There is no substrate included in sample 292. The next layer is a heterogeneous buff paint, then either reddish brown, off-white or yellowish brown paints, depending on the figuring of the graining. Samples 292 and 293 both have the second-scheme 'oak' graining as the upper layers; sample 292 is quite plain with an initial yellow layer then two pale layers, but sample 293 has both pale layers and a deeper buff paint on its surface, relating to the figuring of the oak graining.

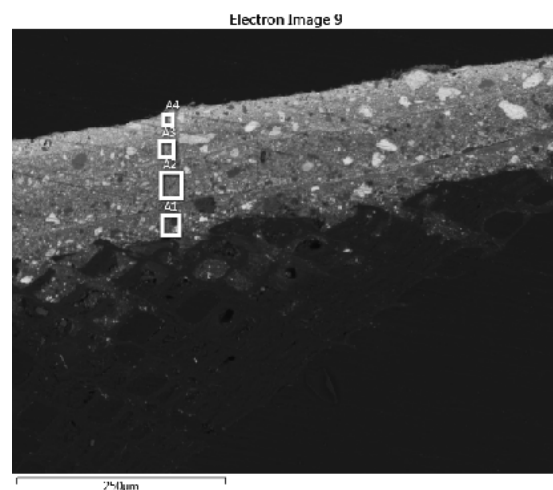
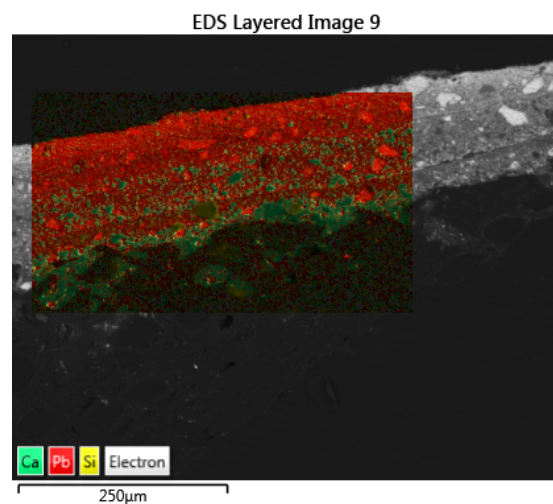
Spectrum 1 identifies lead, iron, calcium, silicon and aluminium.  
 Spectrum 2 detects lead and calcium.  
 Spectrum 3 identifies lead.  
 Spectrum 4 detects lead and calcium.

*Above, overall:* Scanning-electron microscopy (SEM) and EDX of sample 293. *Above top left:* Backscattered-electron image of sample 293 with EDX spectra areas marked; *above, top right:* Cross-section photographed under dark-field illumination photographed at 100× magnification (printed magnification not calculated); *above, lower left:* Backscattered-electron image of the sample with elements mapped in colour (calcium (Ca) is green, lead (Pb) is red, silicon (Si) is yellow); *above, lower right:* EDX spectra 1-4.

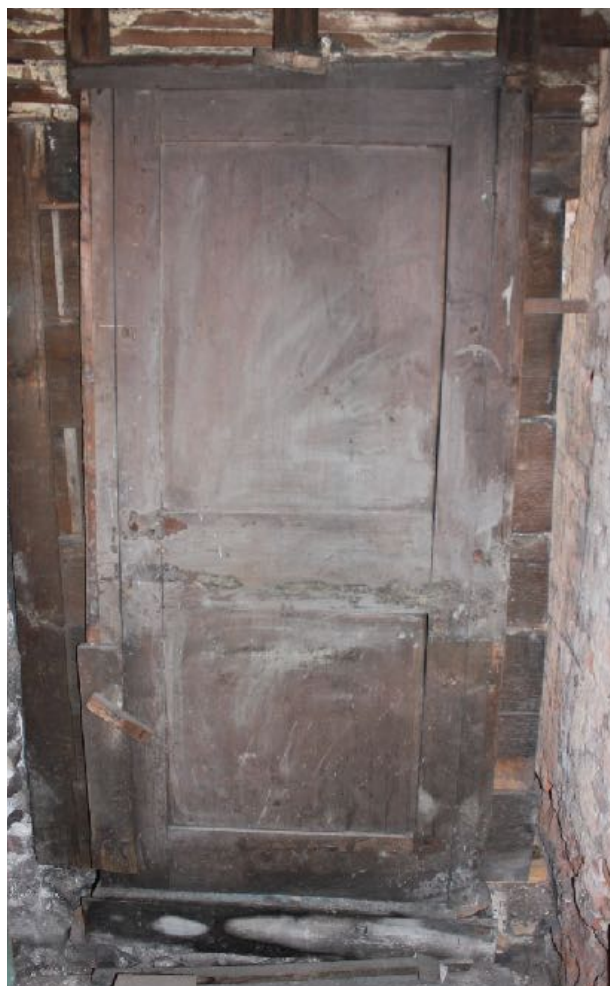
Original scheme  
(walnut colour/graining?):  
Brown on paler brown U/C  
Warm brown-red  
priming  
Timber substrate

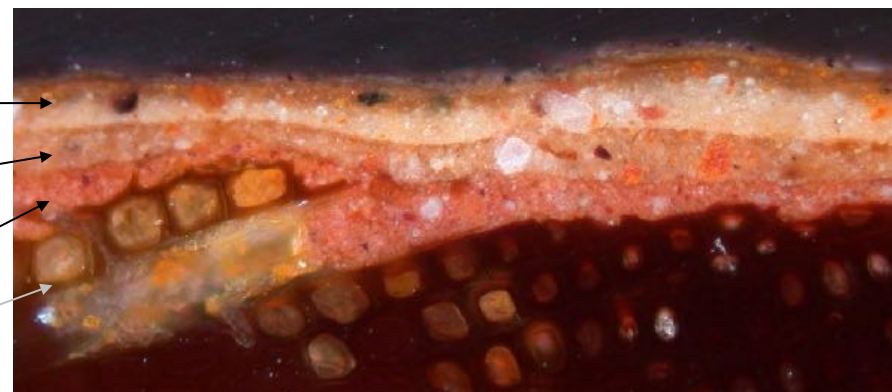
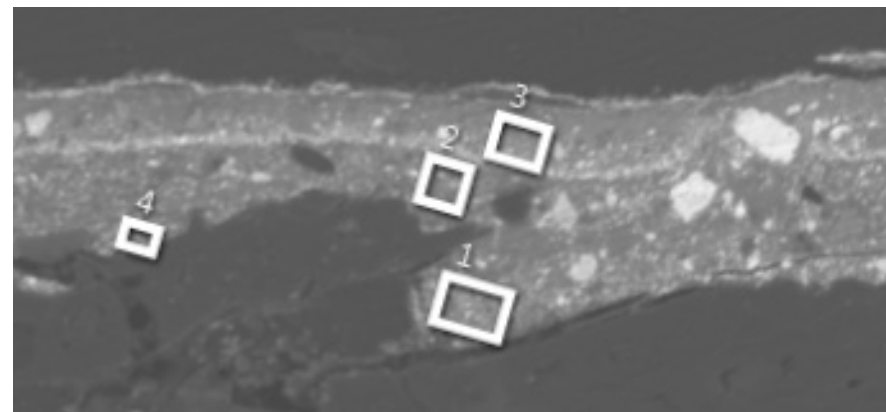
EDX spectra for the regions indicated in the right-hand image suggest red and white lead, natural earth as umber plus chalk in the red priming. Spectra 2 and 3 both suggest white and red lead plus iron oxide natural earth pigments and a little chalk.

*Above left:* Sample location of cross-section 171, from the locking rail of the ground-floor door between 4 and 5 Tower Green (No. 5, 4.3 (2) N. wall, 1630/80s door to No.4); *above, top right:* Sample 171 photographed in cross-section under dark-field reflected light at 200× magnification (printed magnification not calculated). The paint scheme on this sample is almost identical to the painted panelling samples as 288-293; *above, lower right:* Backscattered image showing locations for EDX spectra,

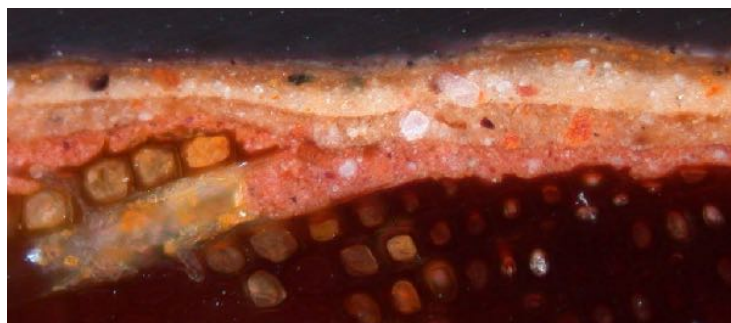
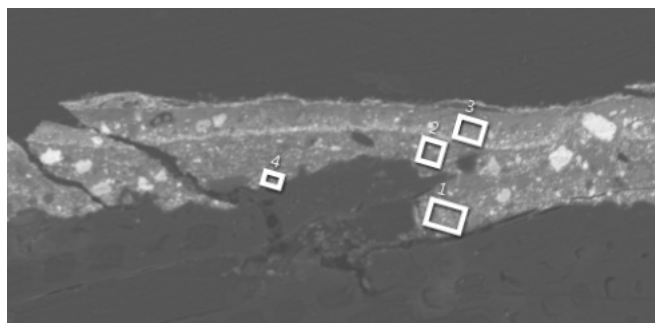
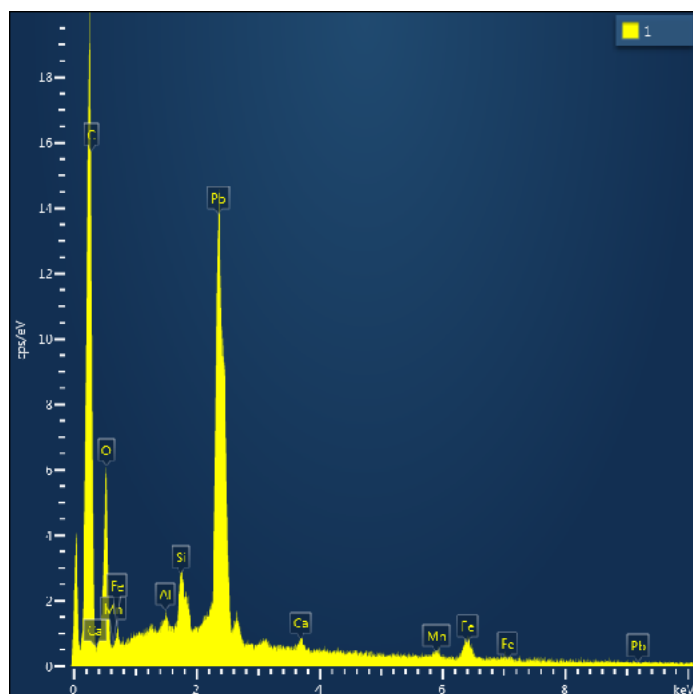
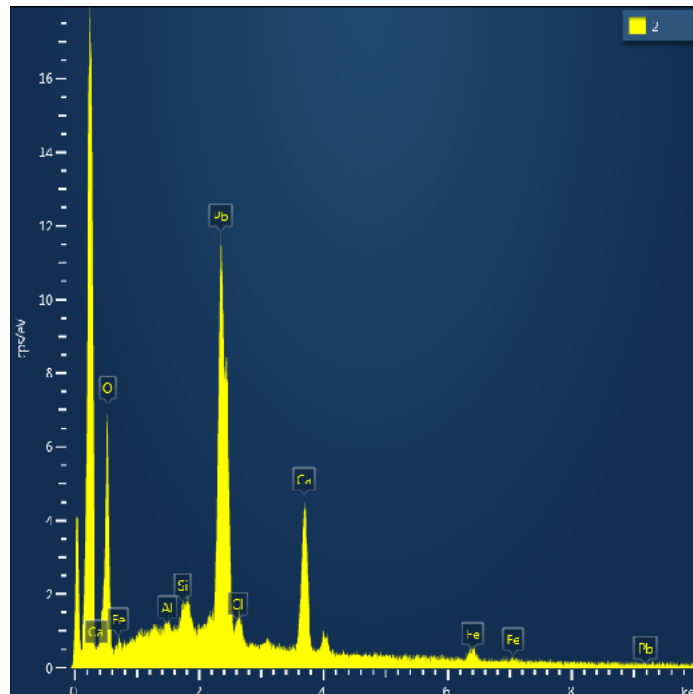
Spectrum 1 (far left) identifies lead (Pb), and traces of iron (Fe), manganese (Mn), silicon (Si) and aluminium (Al), plus calcium (Ca). These suggest red and white lead, natural earth as umber, plus chalk.

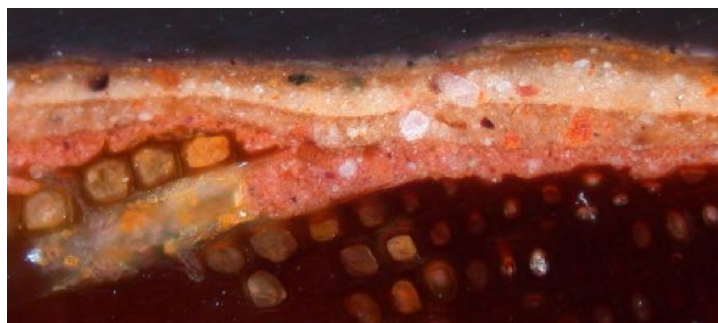
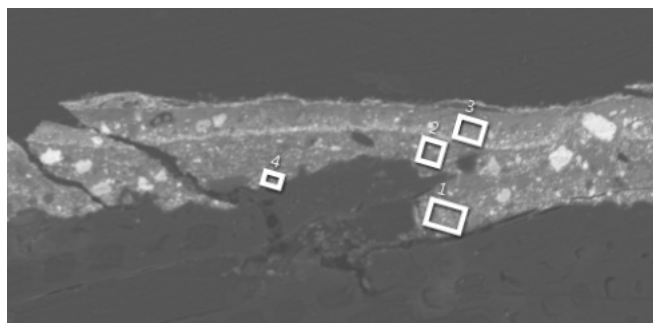
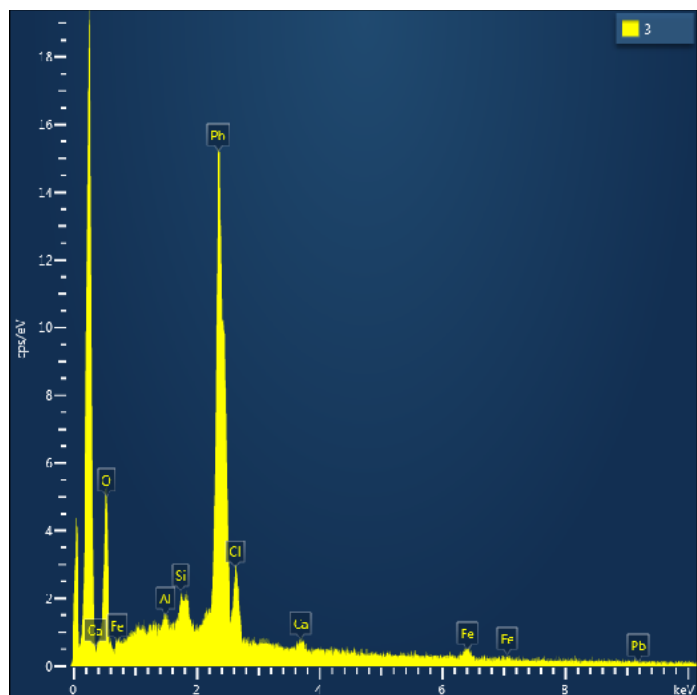
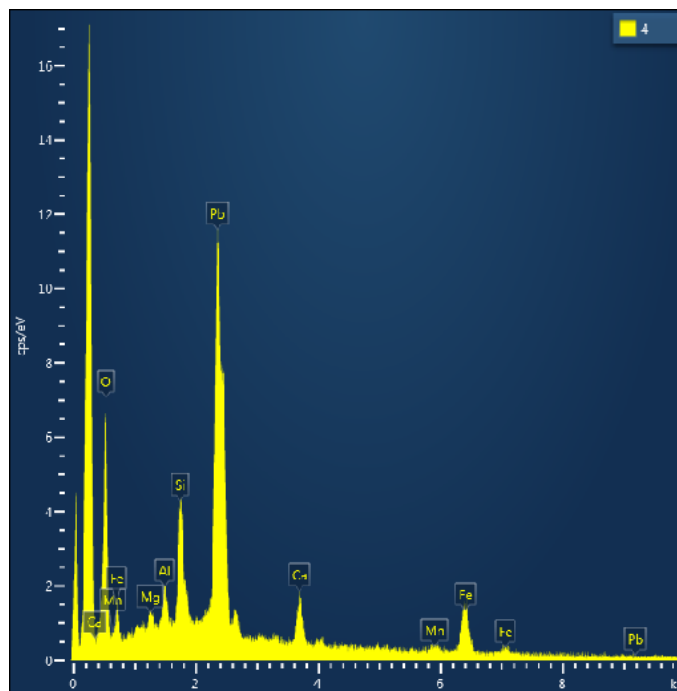
Spectrum 3 (far left) identifies lead (Pb), and traces of iron (Fe), silicon (Si) and aluminium (Al), plus calcium (Ca). The layer appears to contain white and red lead plus iron oxide natural earth pigments and a little chalk.

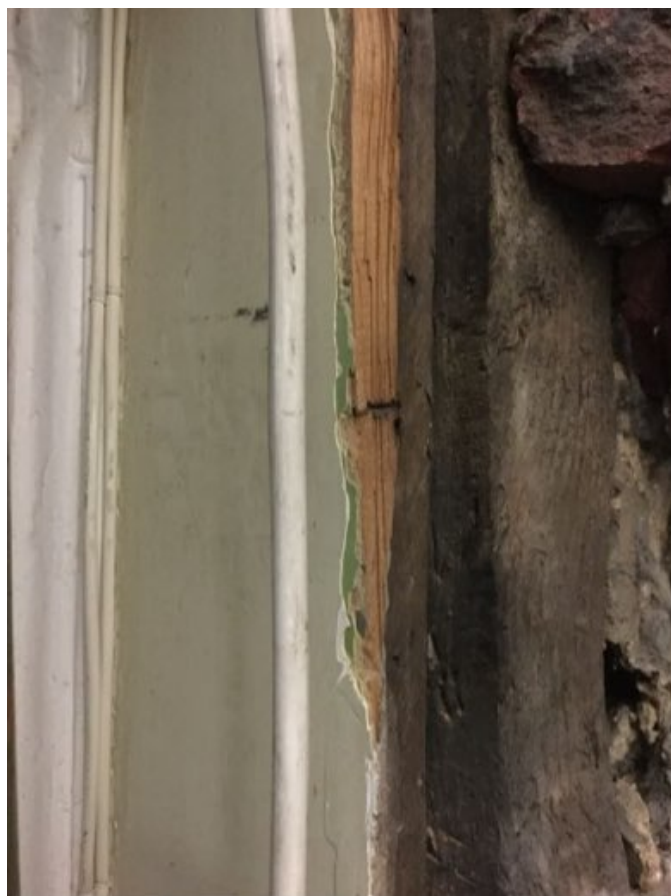
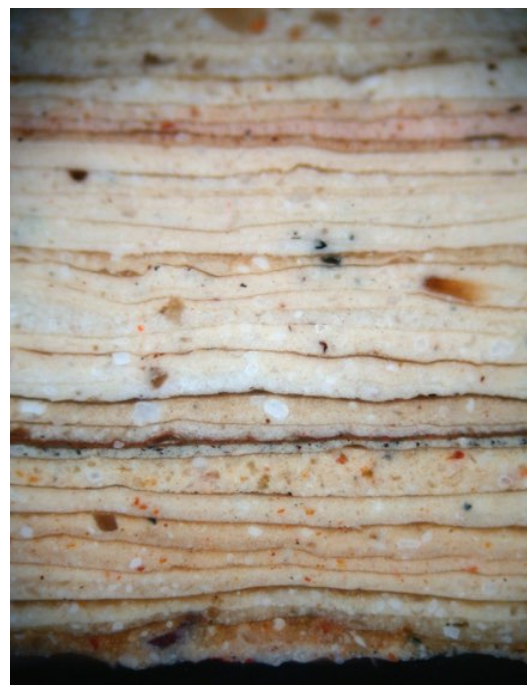
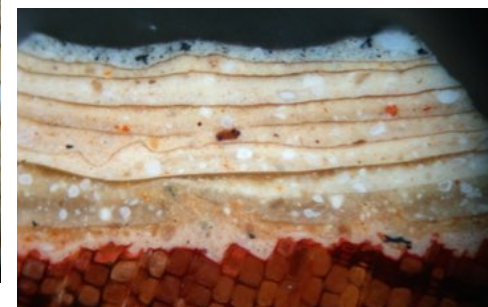
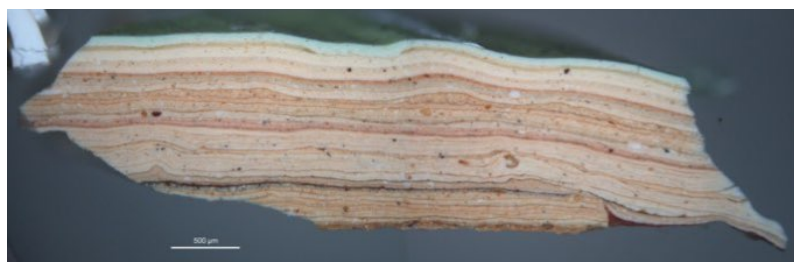
*Overall:* Sample 150 (2 fragments) from panelling between 5G.16 and entrance door.

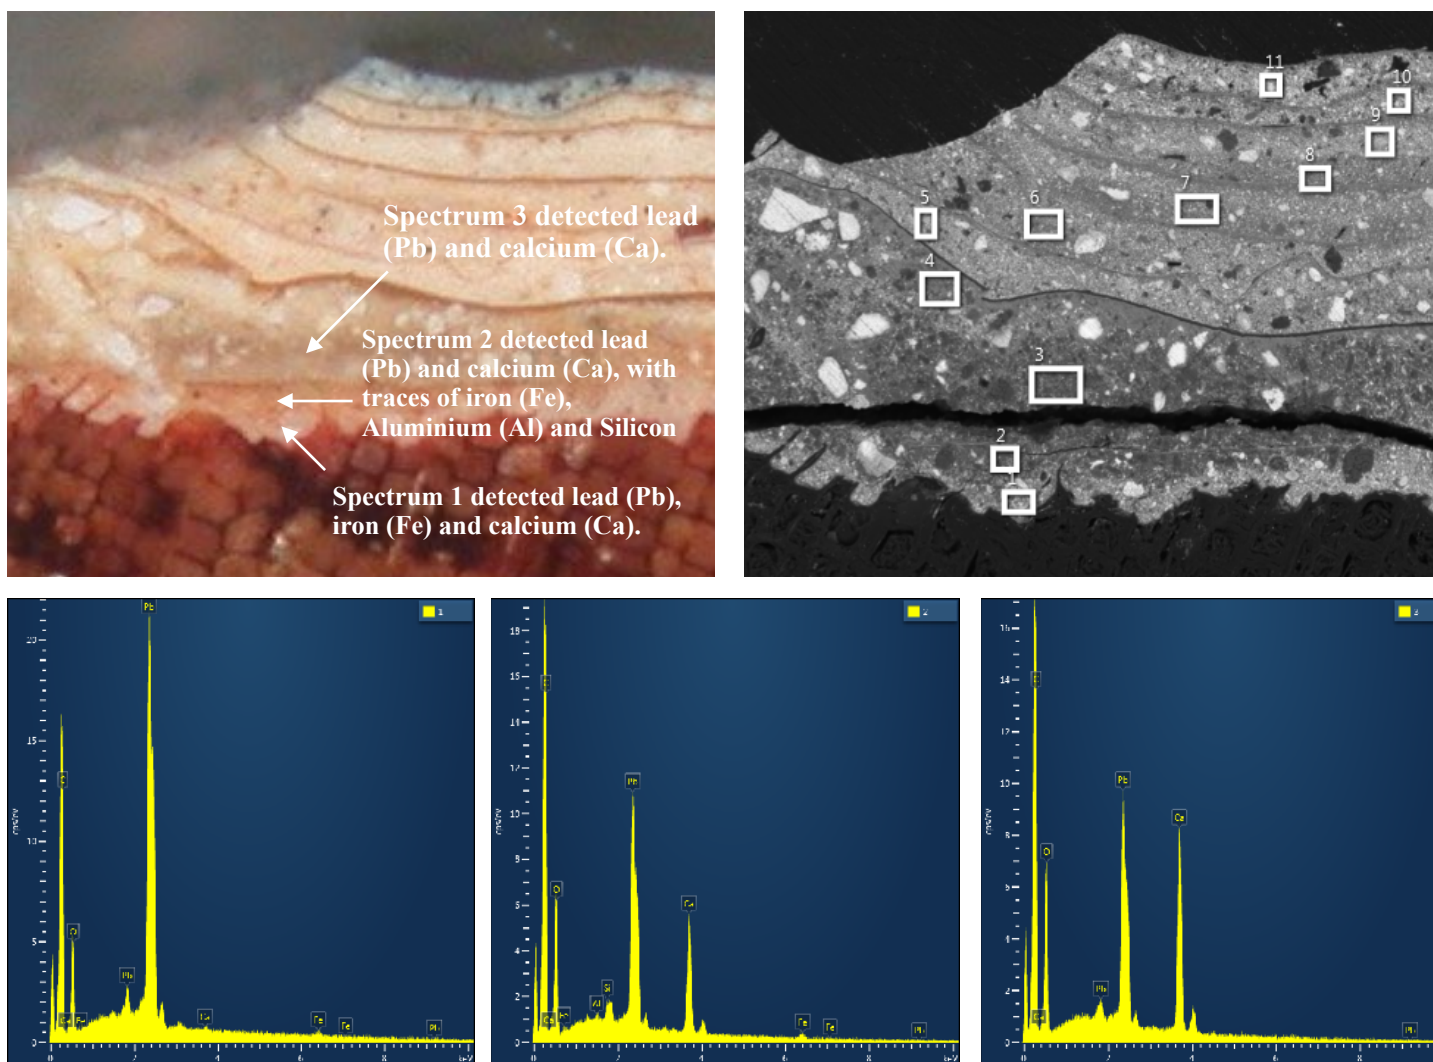
*Above, top left:* Sample 150 (from panelling near entrance of number 5) photographed in cross-section under dark-field illumination at 200× magnification (printed magnification not calculated); *above, top right:* Backscattered-electron image with spectra areas marked up; *above, lower row left-right:* Sample 150 SEM-EDX spectra 1, 2 and 3.

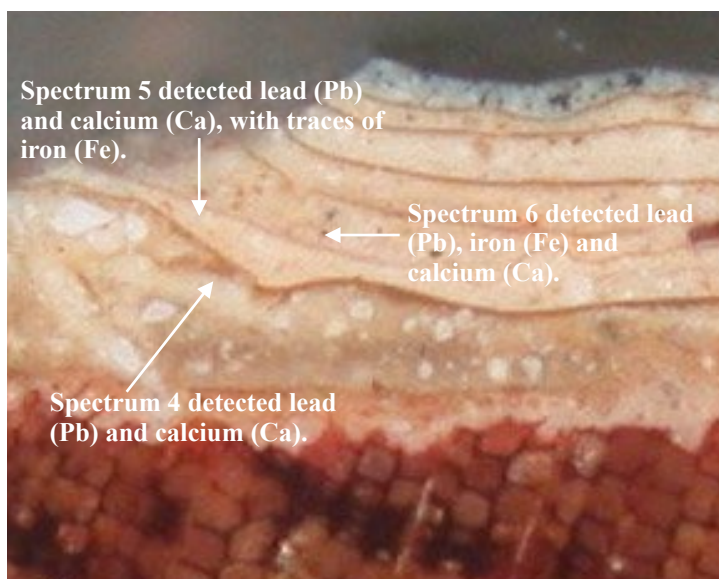
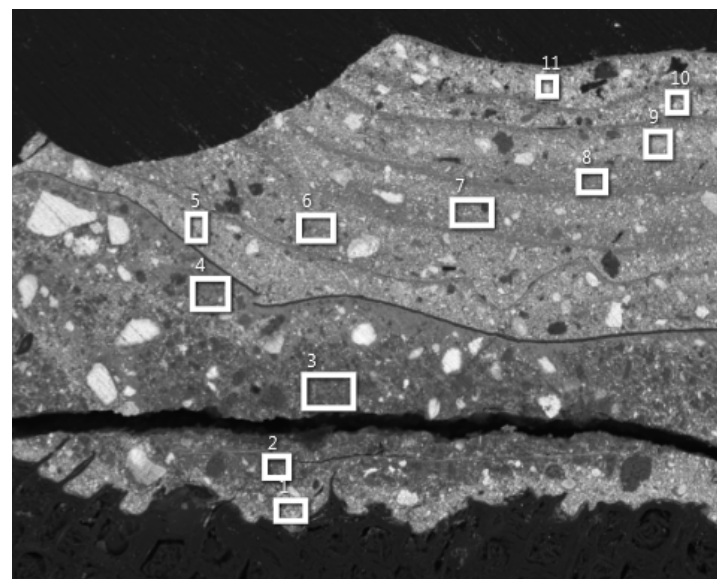
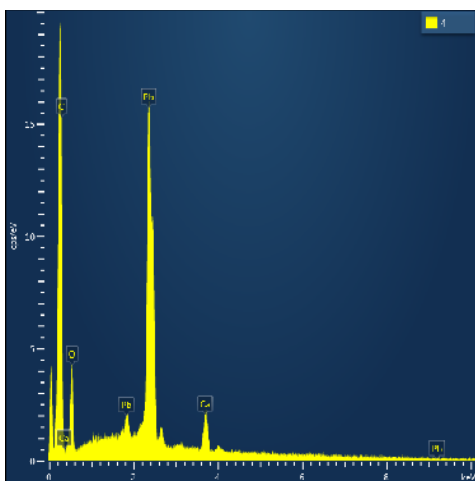
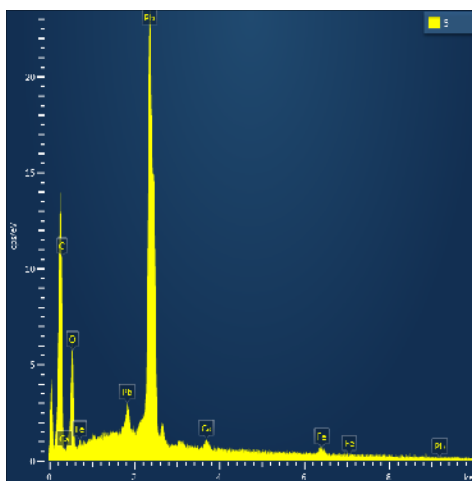
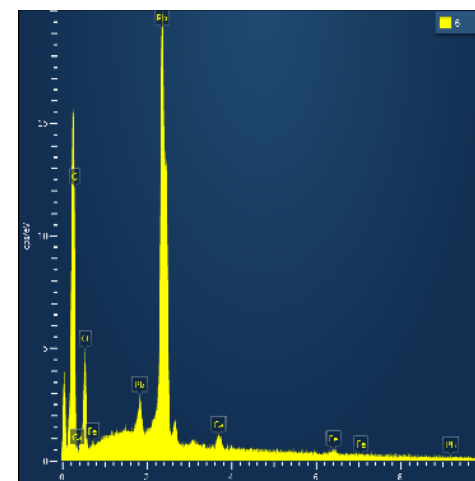
*Above, top left:* Sample 150 (from panelling near entrance of number 5) photographed in cross-section under dark-field illumination at 200× magnification (printed magnification not calculated); *above, top right:* Backscattered-electron image with spectra areas marked up; *above, lower row left-right:* Sample 150 SEM-EDX spectra 4, 5 and 6.

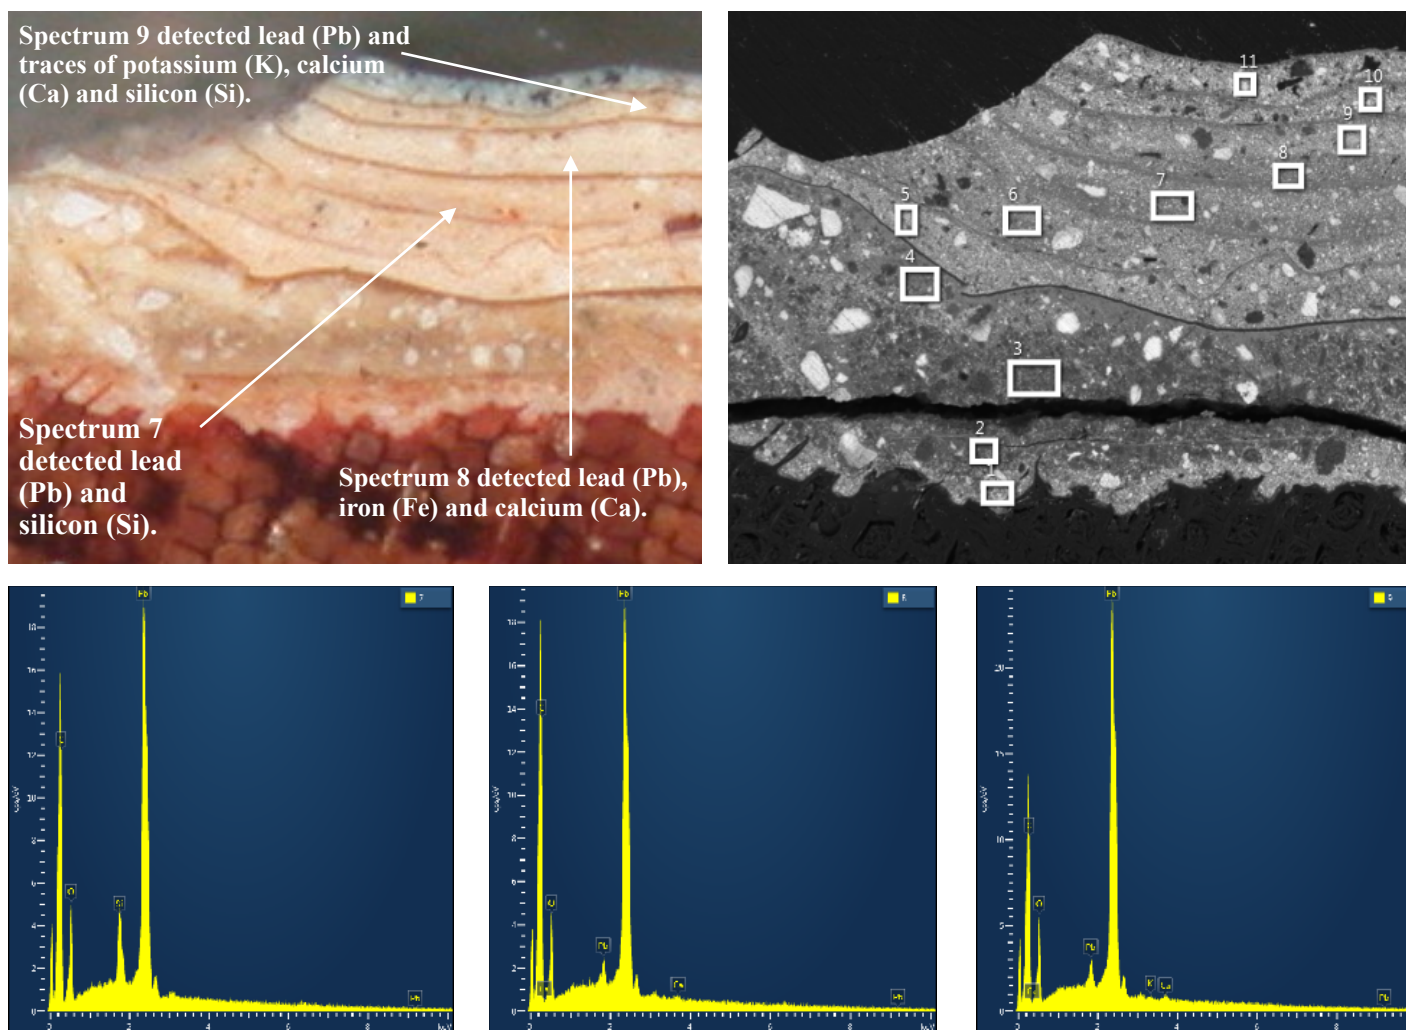
*Above, top left:* Sample 150 (from panelling near entrance of number 5) photographed in cross-section under dark-field illumination at 200× magnification (printed magnification not calculated); *above, top right:* Backscattered-electron image with spectra areas marked up; *above, lower row left-right:* Sample 150 SEM-EDX spectra 7, 8 and 9.
