# JANE DAVIES CONSERVATION

## Architectural Paint Research

### 4 & 5 Tower Green, Tower of London

**May 2018**

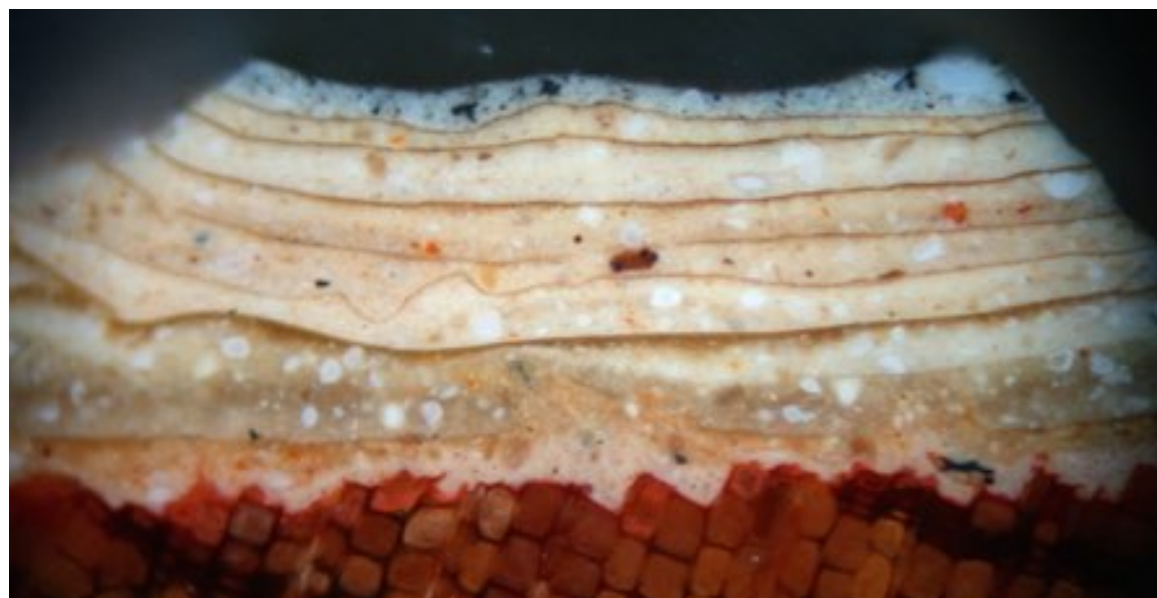
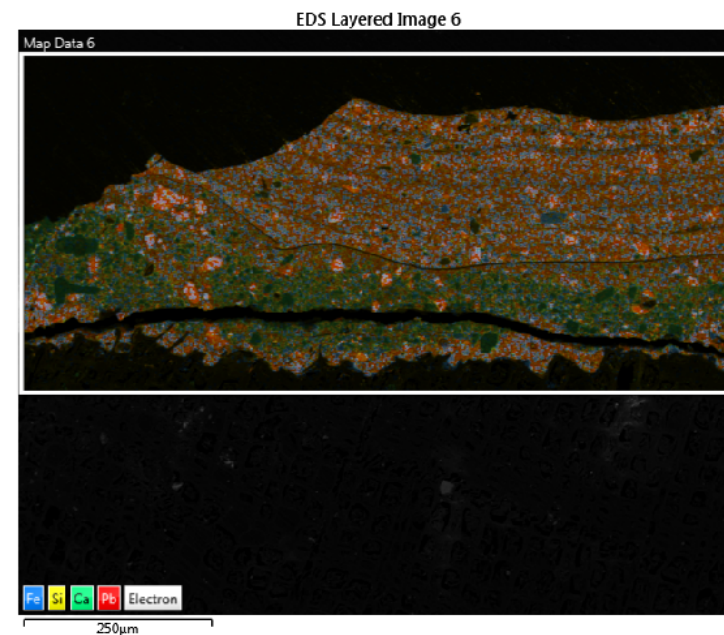
Fe K $\alpha$ 1Ca K $\alpha$ 1Si K $\alpha$ 1Pb M $\alpha$ 1

*Above, overall:* SEM.EDX mapping of sample 150 (fragment containing lower layers) identifies the location of key elements: iron (Fe) mapped in blue, calcium (Ca) mapped in green, silicon (Si) mapped in yellow and lead (Pb) mapped in red.

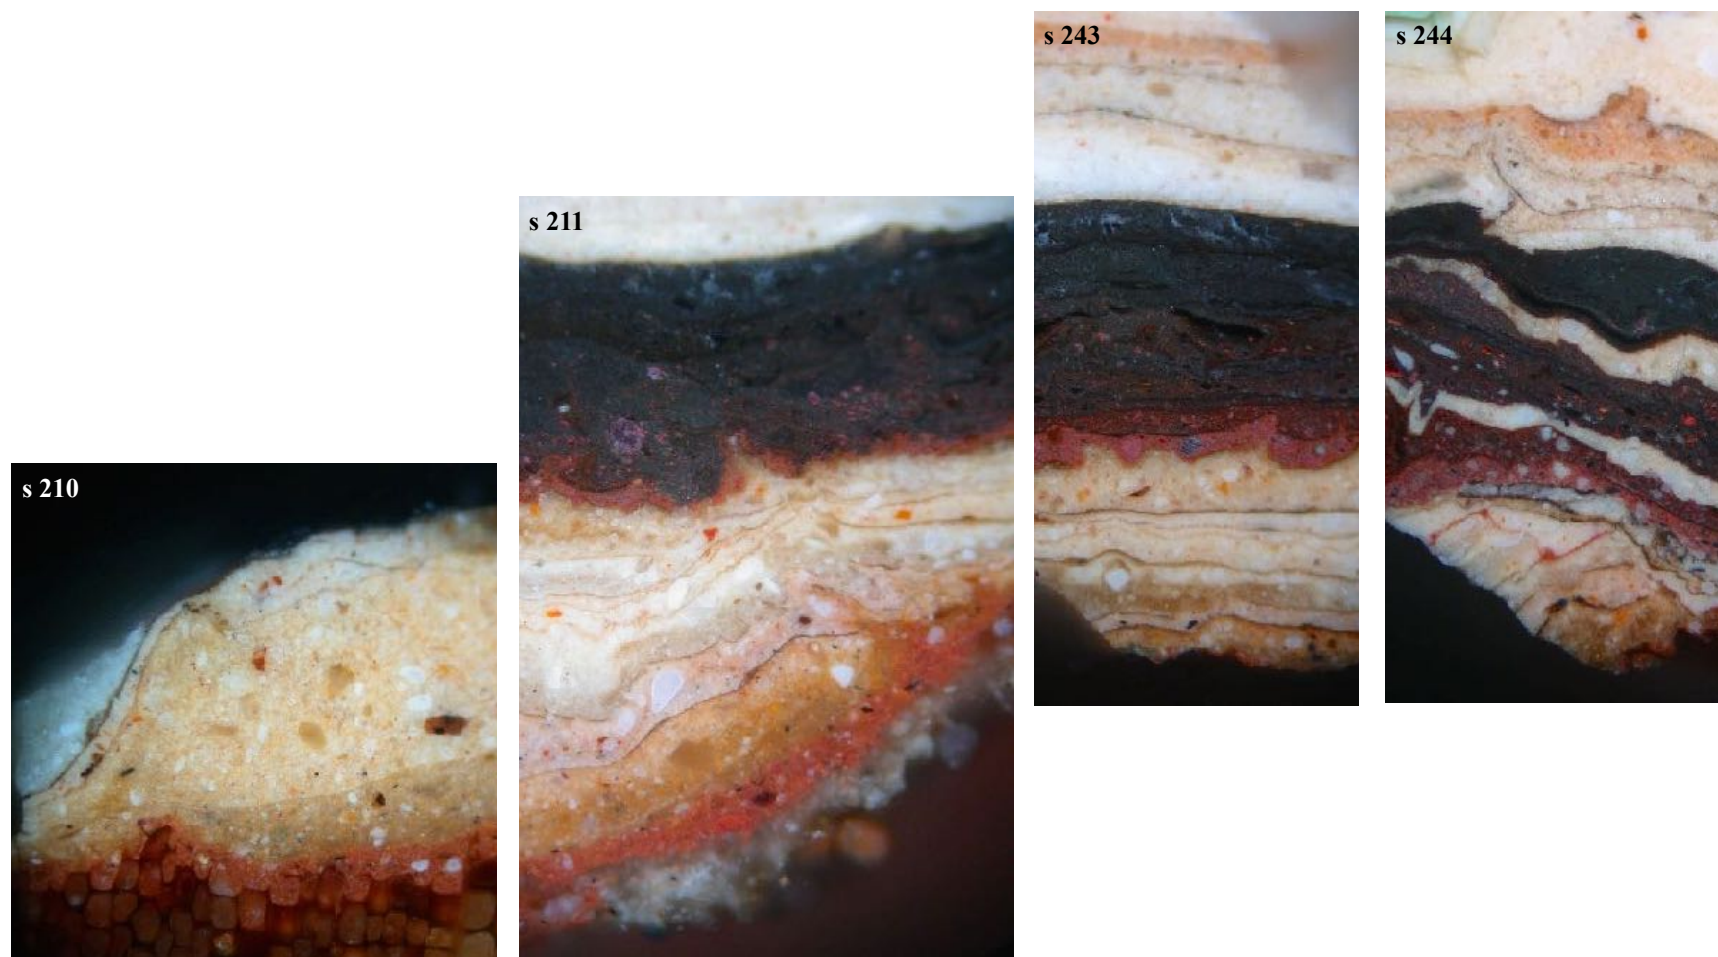
*Above, overall:* Examples of paint samples which show very similar primary layers.

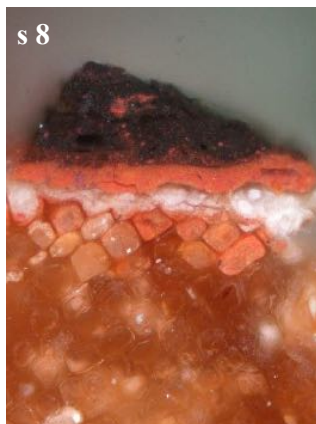
Sample 8 has some characteristics which might at first glance appear to indicate a 17th-century date. The stratigraphy is as follows: the red lead and red iron oxide priming can be clearly seen on and within the upper cells of the timber substrate; this is followed by a medium-rich and partially translucent white-lead-based layer, which also has an appearance that is misleadingly characteristic of 17th-century paint; over this is a red lead and iron oxide red ground layer, a layer of mixed carbon black and red lead, followed by darker paint layer with a little red lead. Despite the appearance of these layers, when compared with samples such as 211 which have retained a full paint history it appears that the first paint layers on sample 8 are likely to be slightly later, probably dating from the 18th century. This would fit better with stylistic evidence which suggests the door is 18th-century. Reddish primings continued to be used as preparation for timber in the 18th century and do not necessarily indicate a 17th-century date.

*Far-left and centre-left:* Sample 8 (from house no.4, ground floor, inner face of entrance door) photographed in cross-section at 200× and 500× magnification.

Two paint samples – 8 and 258, from the inner face of the ground-floor entrance door of house 4 and a newel post from one of the staircases of house 5 respectively – bear paint schemes which are superficially similar to the earliest paint. They are, however, considered likely to be anomalous, later schemes, rather than original material.

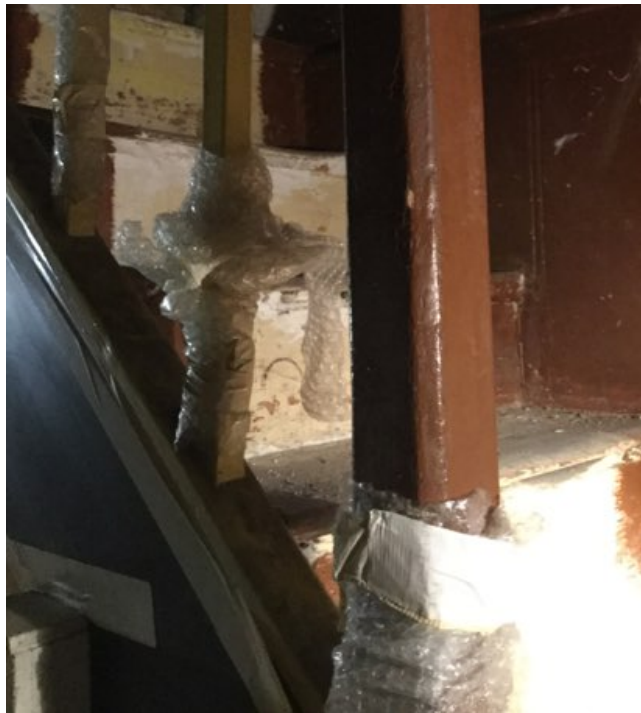
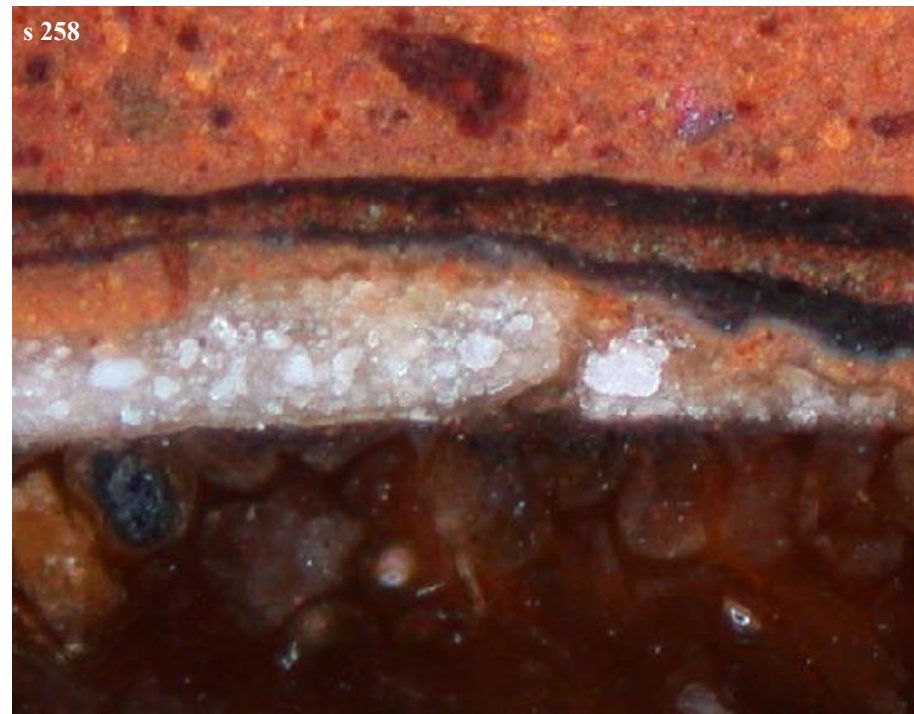
Likewise, sample 258 appears to be anomalous later paint with a superficial resemblance to the earliest paint seen elsewhere. This sample was taken from the newel post of the stairs from the ground floor middle room to the basement of house 5. The cross-section shows that the first scheme in this region bears no priming, but the translucent lead white followed by layers of iron oxide and red lead appear similar to 17th-century paintwork. However, this staircase has been dated to the early 19th century, possibly 1840s, on stylistic grounds: there is evidence of stop chamfering on the balusters and Charles Brooking noted the spacing of the balusters as being unusual.<sup>16</sup> Therefore, it is considered likely that the paint on this element dates from the 19th century. Lead white, iron oxide and red lead are all pigments that were in use well into the 19th century and, to varying extents, into the 20th century, so their presence in a 19th-century paint layer is not problematic.

*Above left:* Sample 258 location; *above right:* Sample 258, photographed in cross-section under dark-field reflected light at 500× magnification (printed magnification not calculated).

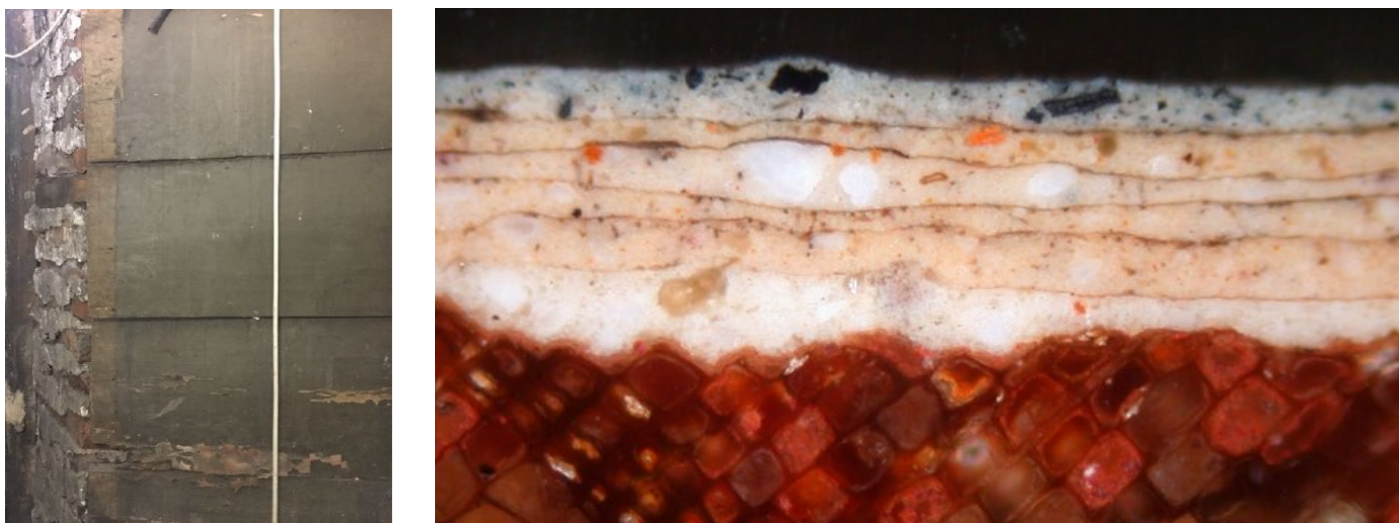
The earliest paint on the horizontal plank panelling to the south to the main entrance in the hall of house 5, seen in cross-section as sample 151, starts with a fairly early scheme that corresponds to the third decoration seen in the most complete samples discussed previously. The panelling to the north of the entrance door (sample 150), on the other hand, has the two very earliest paint schemes and may have been moved from elsewhere, already painted twice, when the entrance hall timber elements were formed, either in the very late 17th or, more probably, the early 18th century. It is notable that the panelled region to the south of the entrance door bears no paint after the slightly later-18th-century eighth decoration – a grey mixture primarily composed of lead white and a carbon-based black with the appearance of charcoal, which appears as a dull grey-green colour on the visible paint surface. The grey-green surface appearance is an optical effect which relates to the combination of the grey pigment mixture and the yellowing of the oil binder, which can discolour when not exposed to light for a long period. It is assumed that this panelling was covered over by additional panelling or another finish for the major part of the decorative history of the house. This grey mixture is also seen in the sample from the panelling to the north of the entrance door (sample 151), but in this region it was painted over subsequently. Sample 151 is composed of two fragments of paint, the lowest of which happened to cleave after the grey paint layer, but there is later paint directly over the grey layer seen in the upper paint fragment of this sample.

*Above left:* Sample 151 location (plank panelling to south of entrance door of 5 Tower Green); *above right:* Sample 151 photographed in cross-section under dark-field reflected light at 200× magnification (printed magnification not calculated).

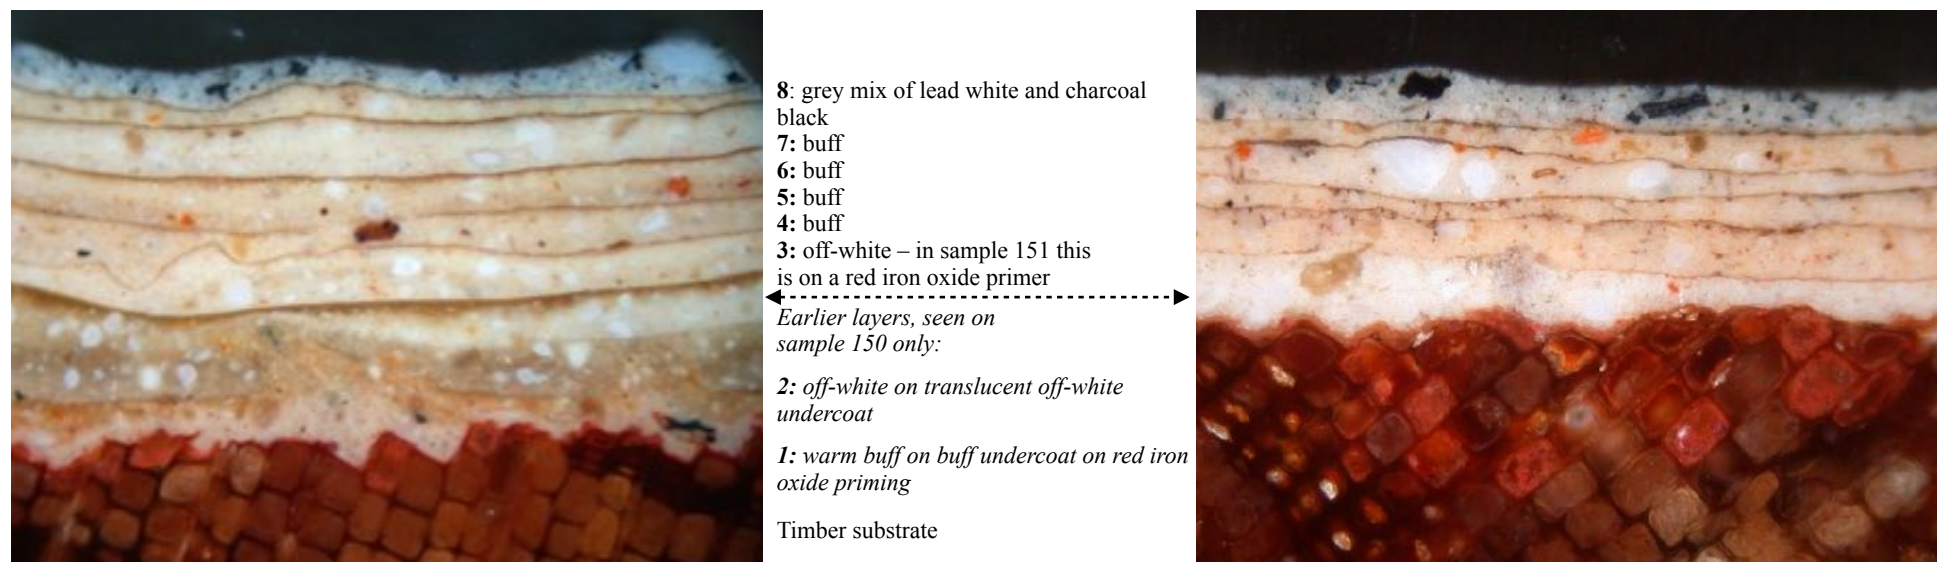
*Above, overall:* Comparison of the 18th-century paint of sample 151 (right) with the lower fragment of sample 150 (left), which includes the earliest 17th-century paint schemes as well as 18th-century paint up to the distinctive grey scheme, which is the uppermost paint layer seen in both cross-sections. The first decoration on the horizontal panel sample from the right side (south) of the entrance door (151) corresponds with the third decoration seen on the panelling to the left (north) of the entrance door (150). Samples are aligned to show the corresponding schemes.

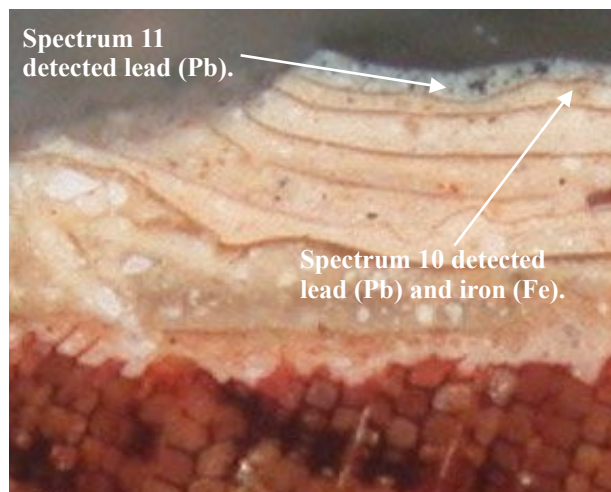
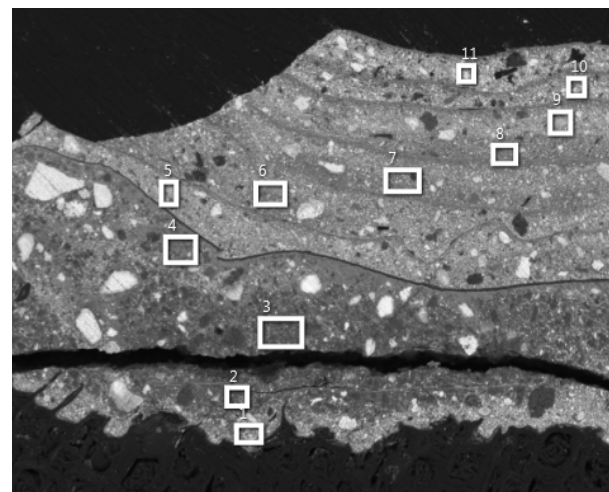
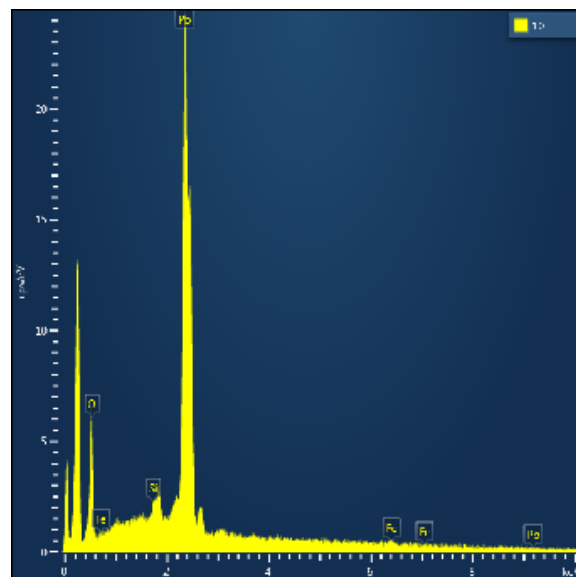
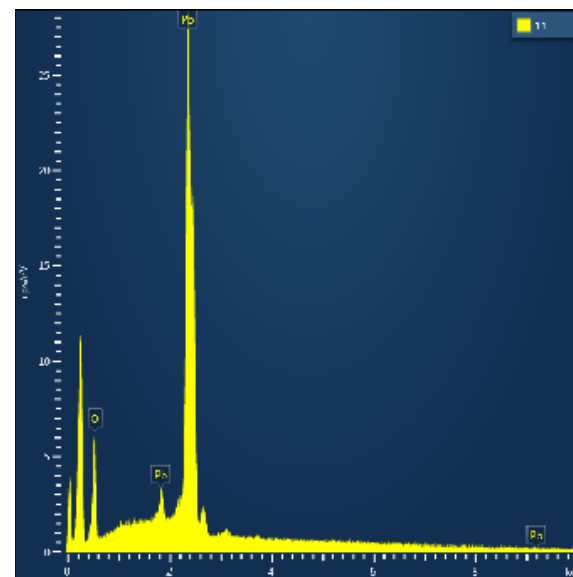
*Above, top left:* Sample 150 (from panelling near entrance of number 5) photographed in cross-section under dark-field illumination at 200× magnification (printed magnification not calculated); *above, top right:* Backscattered-electron image with spectra areas marked up; *above, lower row left-right:* Sample 150 SEM-EDX spectra 10 and 11.

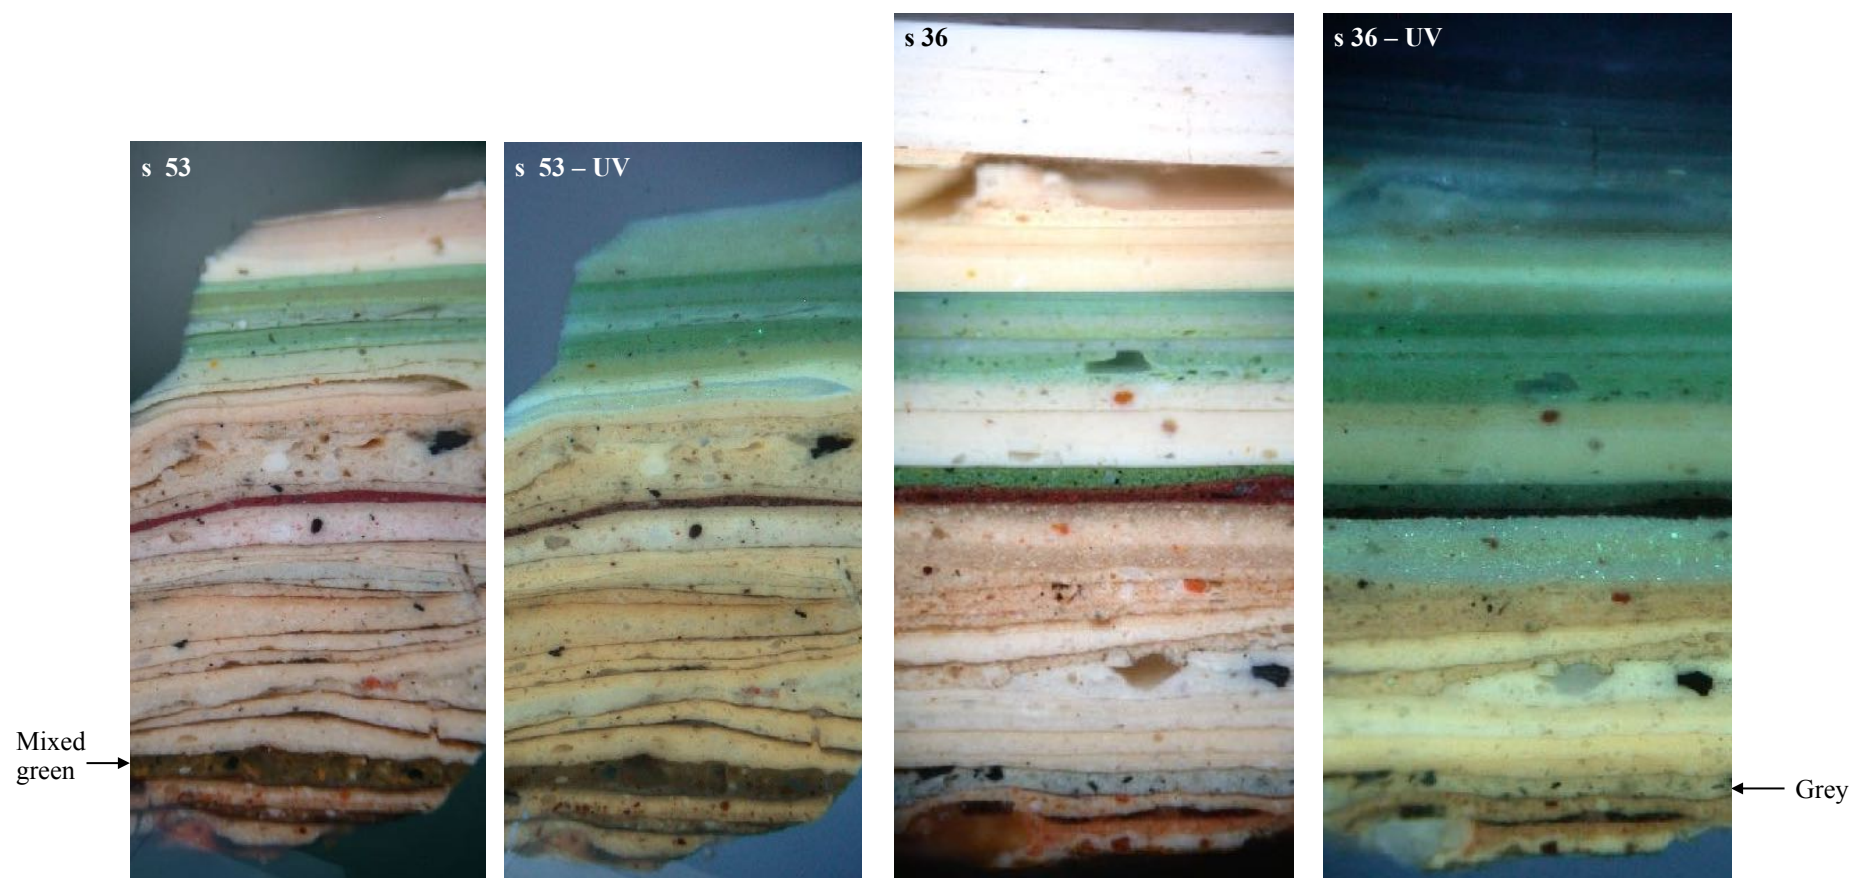
*Above, left and centre-left:* Sample 53 (baluster of staircase between ground and first floors of house 4) showing early graining and a distinctive early green decoration, which appears to be of similar general date to the characteristic grey. Sample photographed in cross-section under dark-field and UV illumination with Leica filter cube A at 100× magnification.

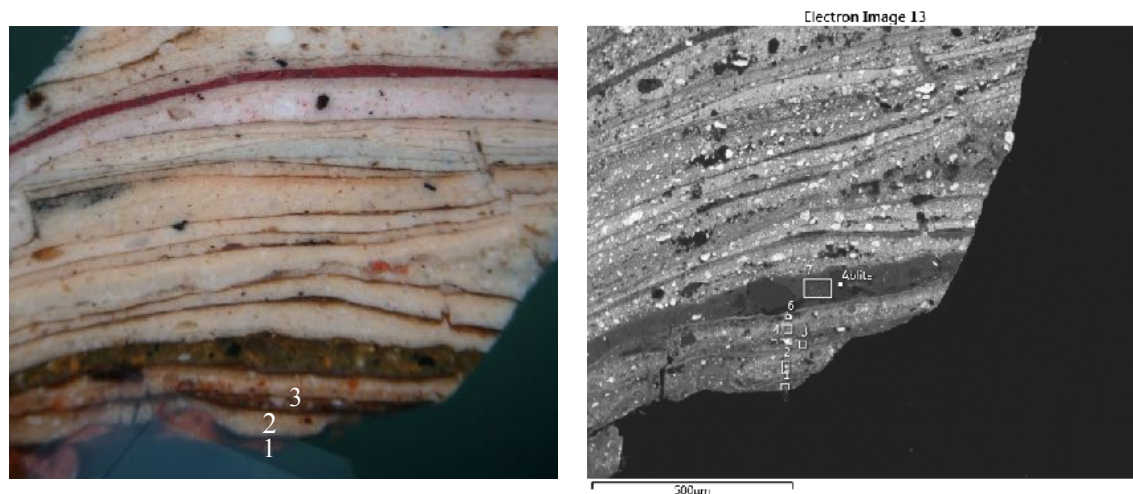
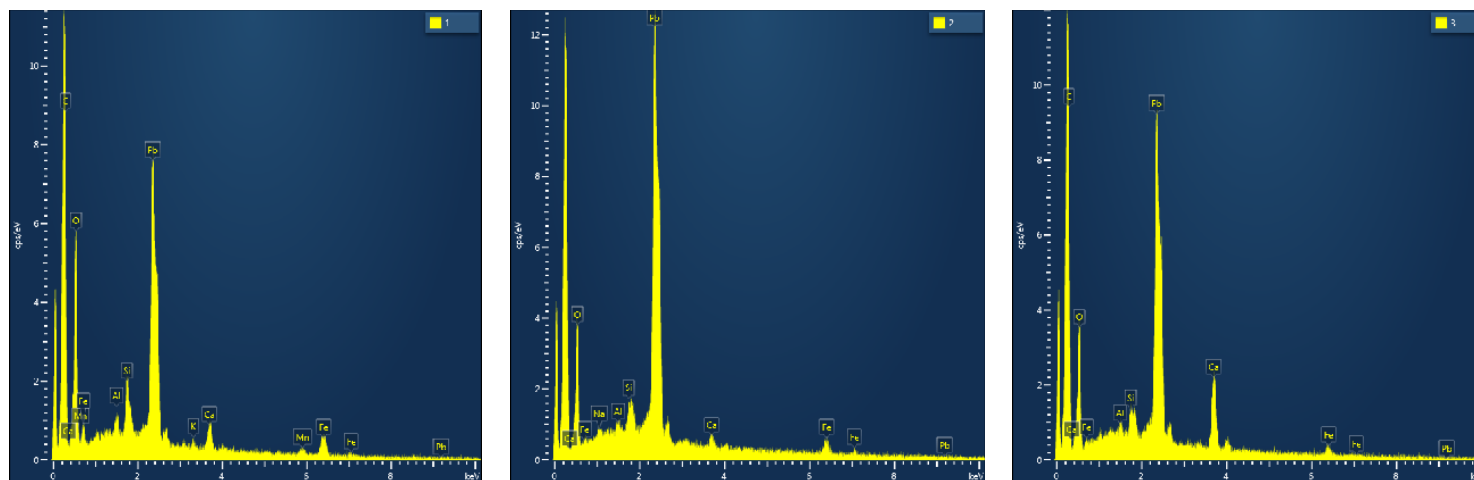
Spectrum 1 identifies lead (Pb), iron (Fe), manganese (Mn), silicon (Si) and aluminium (Al). Given the appearance of the layer this indicates lead white, lead red and some natural brown umber.

Spectrum 3 has similar peaks to spectrum 2, perhaps with a little more calcium (Ca), which may indicate a higher proportion of chalk.

*Above, top left:* Sample 53 (from panelling near entrance of number 5) photographed in cross-section under dark-field illumination at 200× magnification (printed magnification not calculated); *above, top right:* Backscattered-electron image with spectra areas marked up; *above, lower row left-right:* Sample 53 SEM-EDX spectra 1, 2 and 3.

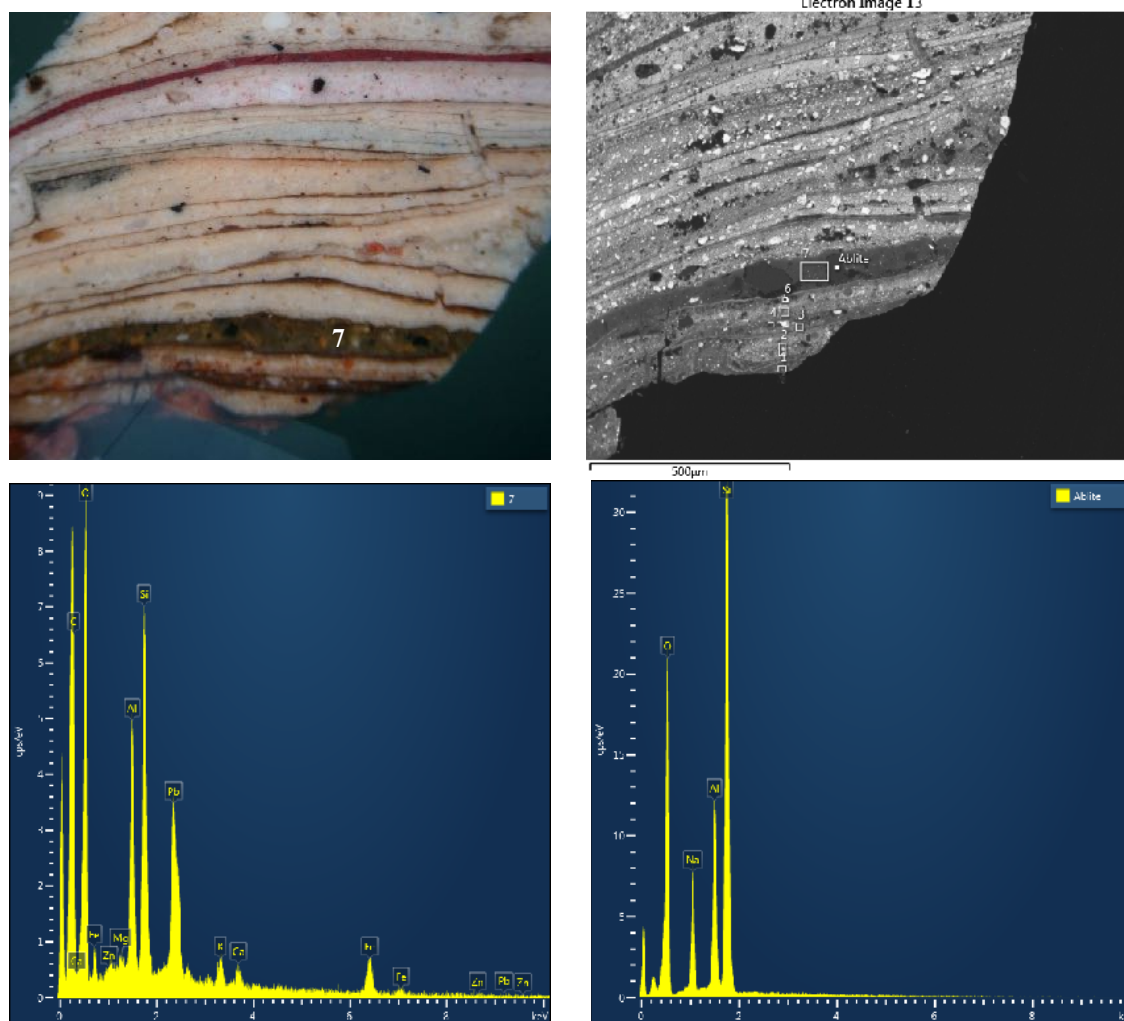
Spectrum 7 identifies lead (Pb), iron (Fe), calcium (Ca), silicon (Si), aluminium (Al), potassium (K), and a trace of zinc (Zn).

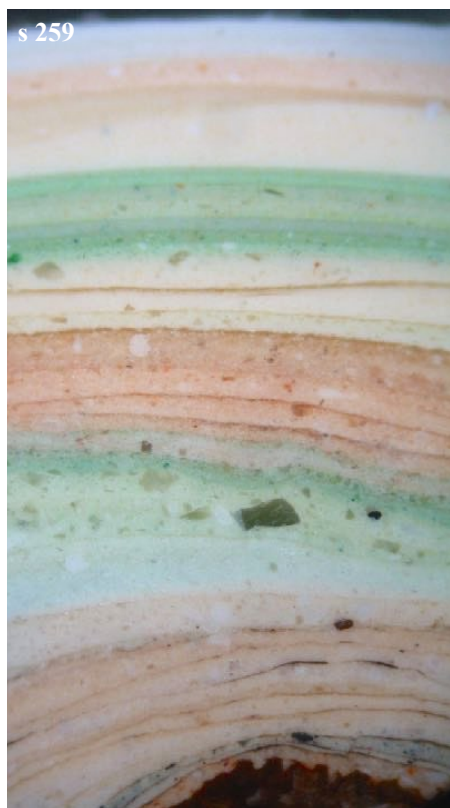
A little red pigment – either red lead or iron oxide – is present in the undercoat (and incorporated in the overlying green paint layer, possibly picked up from the undercoat accidentally), of one of the later of the 18th-century green schemes seen on the plank lining of the house-4 side of the ground-floor internal door between the two houses.

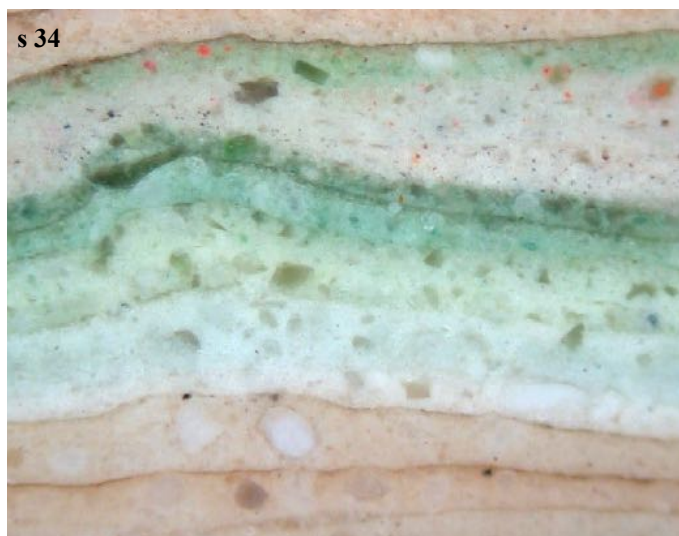
*Far left:* Sample 259 (panelling revealed by removal of asbestos panelling, main ground-floor room of house 4). This sample has evidence from the fifth decoration onwards, including the grey eighth decoration, and a pale blue-green as the 17th decoration, repeated with slight variation in hue at 18th and 19th decorations, followed by five or more buff schemes until the 19th-century introduction of several green schemes (24-28 here). Sample photographed at 200× magnification under dark-field light.

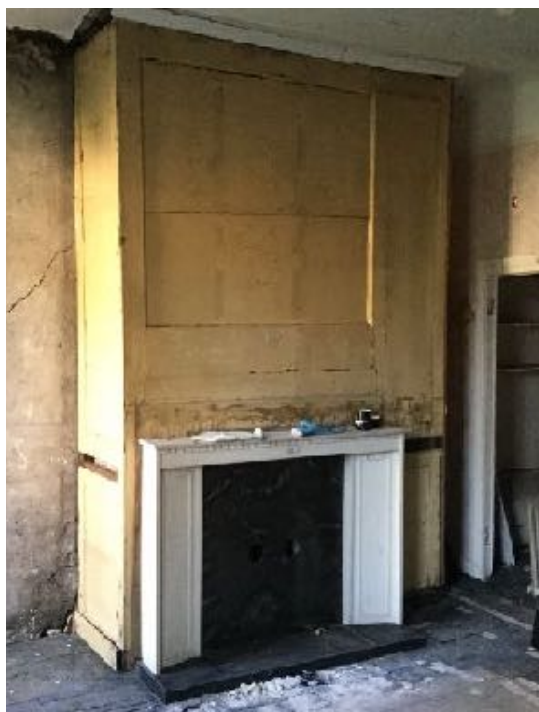
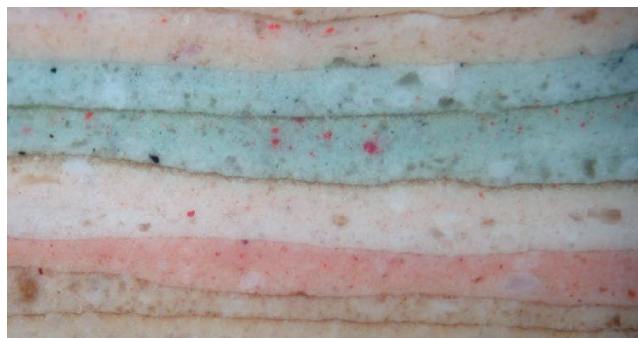
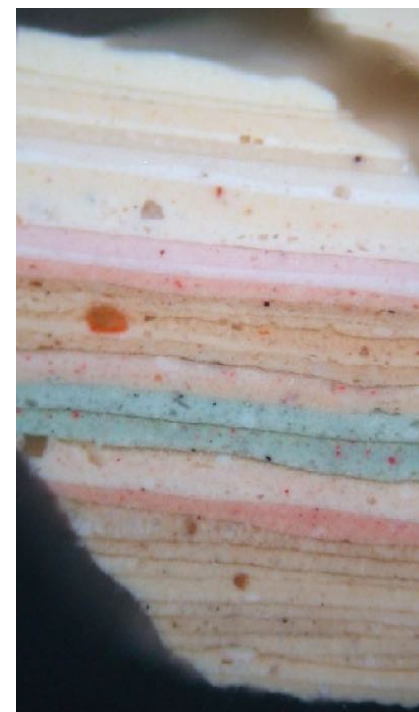
The main first-floor room of house 4 includes high-quality ovolo mouldings as part of the chimney breast, which are believed to date from the late 17th century.<sup>18</sup> The 18th-century paint in this region includes buff paint and two pink schemes – brighter and paler respectively – which may date to the latter part of the 18th century, followed by a pale blue which includes particles of red pigment, and a second similar pale blue without the red pigment. SEM.EDX indicates that these layers contain barium, suggesting a 19th-century date. Several buff schemes are then repeated before the later re-introduction of pink.

*Above left:* Chimney breast in main first-floor room of house 4.

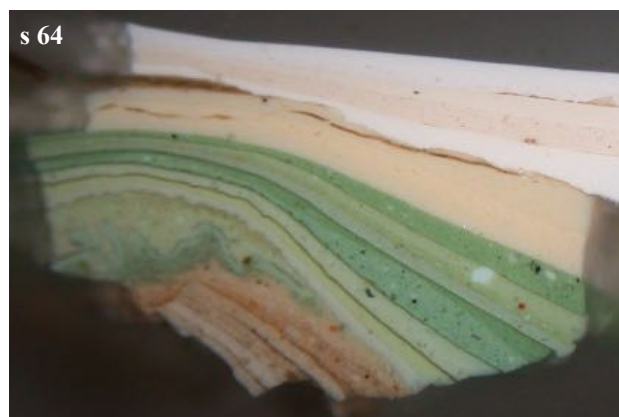
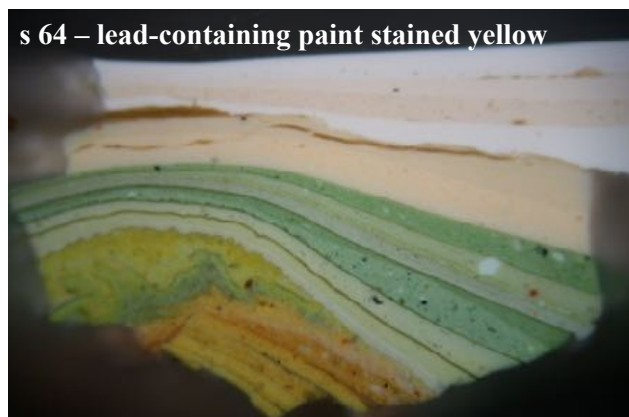
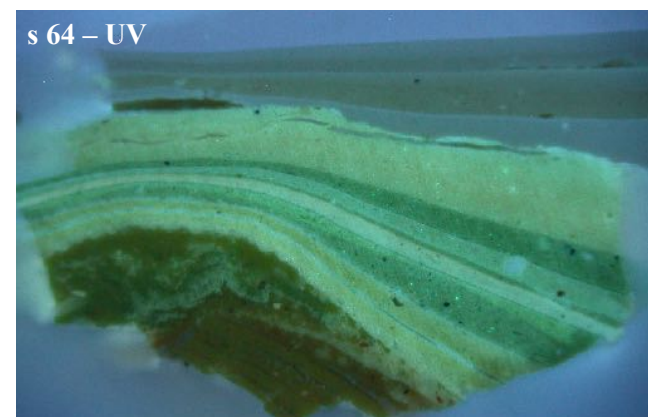
The mid 19th century saw the introduction of zinc-containing paints throughout the properties. These are clearly visible in cross-section due to the distinctive fluorescence of zinc oxide under UV. The transition from the earlier use of predominantly lead-based paints to zinc-white-based paints, and then to titanium-based paints, which incorporate stainers as opposed to coloured pigments, is clearly seen in cross-section 64 from the architrave upright of the doorframe in the second-floor room of 4 Tower Green, below. The early lead-based paints have been stained yellow with potassium chromate in the central image, while the later zinc-based paints appear bright and sparkly in UV in the right-hand image, and the overlying modern paints appear dark under UV in the same image.

*Above left:* Sample 64 photographed in dark-field reflected light at 100× magnification; *above centre:* As before after staining for lead with potassium chromate; *above right:* Sample 64 after staining for lead with potassium chromate under UV illumination with Leica filter cube A. Printed magnifications not calculated.

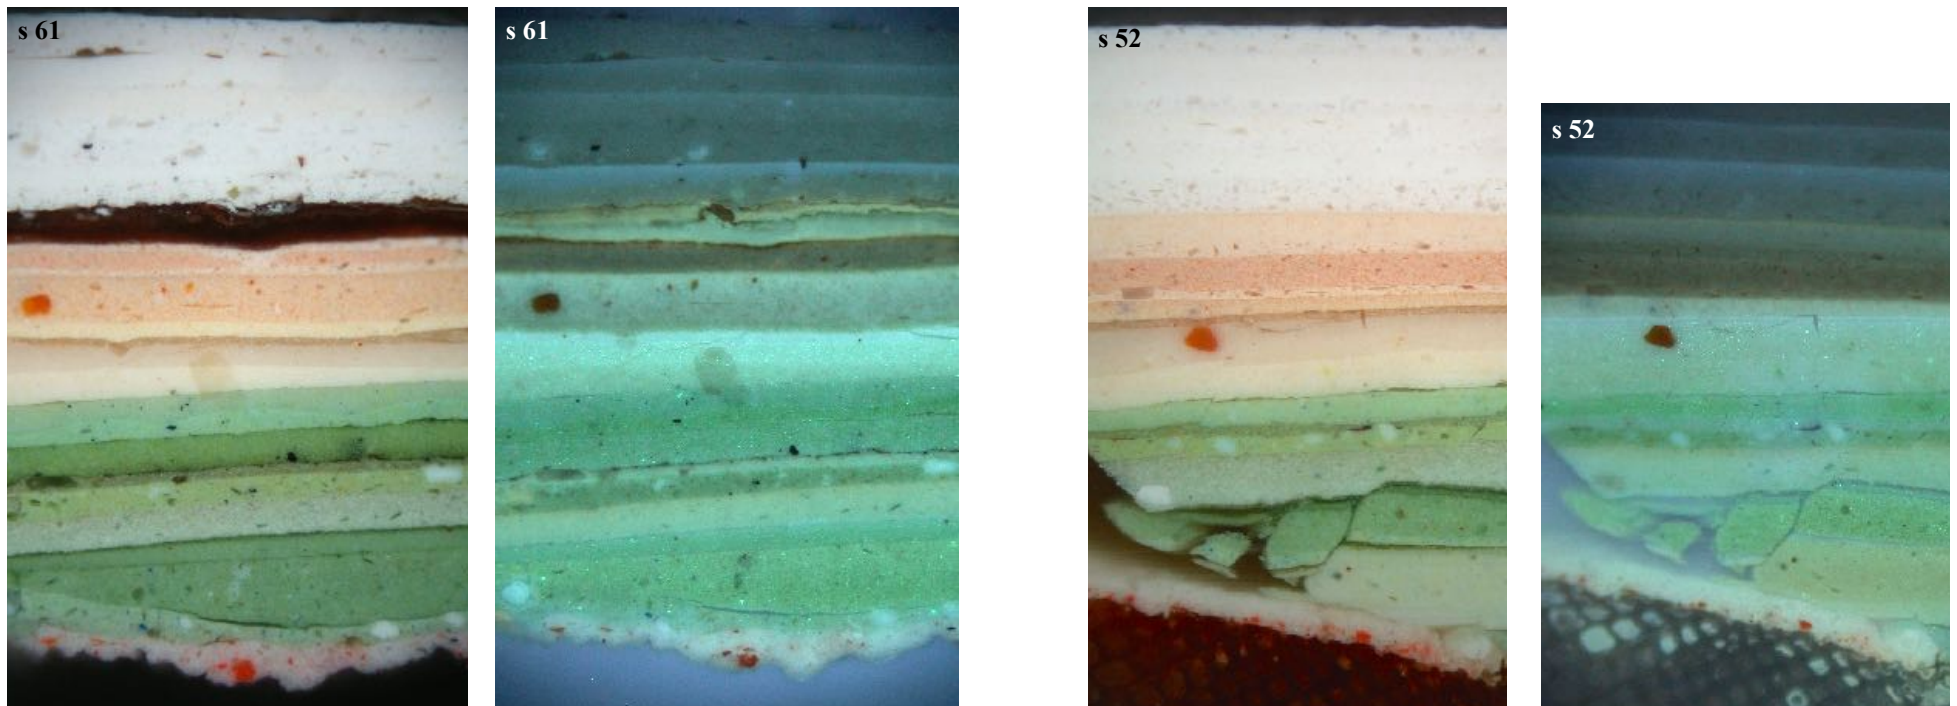
Some architectural elements, such as parts of the skirting and wall panelling on the staircases of house 4, were 19th-century repairs or additions. These elements often have a distinctive mixed pink priming, which is typical of 19th-century paintwork. A mid-19th-century zinc-containing green is seen directly on the pink priming, and is followed by several similar schemes, before being painted off-white, peach, pink and white.

*Above, left and centre-left:* Sample 61 (from the skirting of the first-to-second-floor staircase of house 4) photographed in cross-section at 200× magnification under dark-field reflected light and UV light with Leica filter cube A.

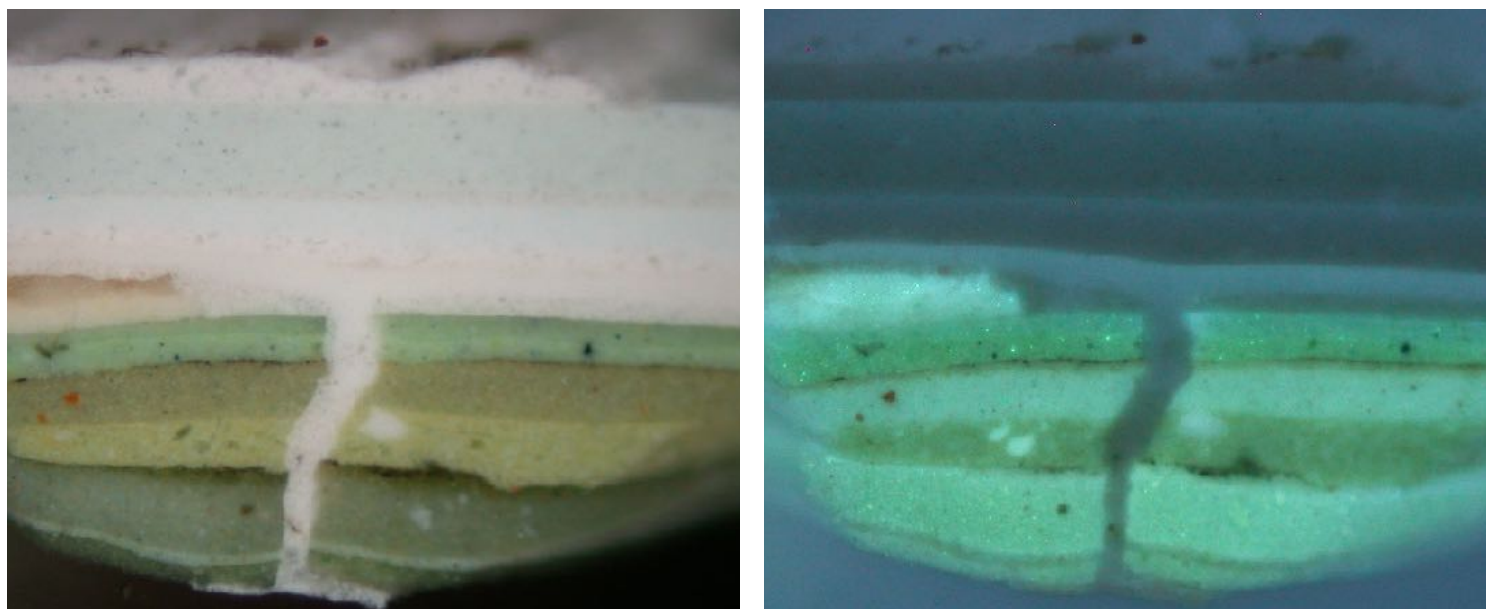
Paintwork dating from the second half of the 20th century to the present day tends to consist of alkyd paints coloured with stainers as opposed to pigments, which are typical of this period. These paints tend to appear very pale in cross-section when viewed under dark-field reflected light but appear much dark under UV illumination than the preceding zinc-containing oil-bound paint layers, which have a sparkly appearance under UV.

*Above, left and right:* Sample 7 (interior entrance door frame, hallway, house 4) photographed in cross-section under dark-field reflected light and under UV illumination with Leica filter block A, both at 200× magnification. Printed magnification not calculated.

The mid- to late-20th-century alkyd paint layers appear pale under dark-field light and dark under UV, whereas the earlier oil-bound paints, here containing zinc white, fluoresce. The more modern paint can be seen running into a crack in the earlier oil-bound paint.
